MATERIAL RENOVATION

To create a realistic proposal for renovating and restoring Crown Hall to Mies Van der Rohe's original vision while still keeping the building functional for today. By following guidelines for its new landmark status and last semester's research on the high priority problems of the building we created a plan of restoration that is hopefully comprehensive enough to put into effect as soon as possible.

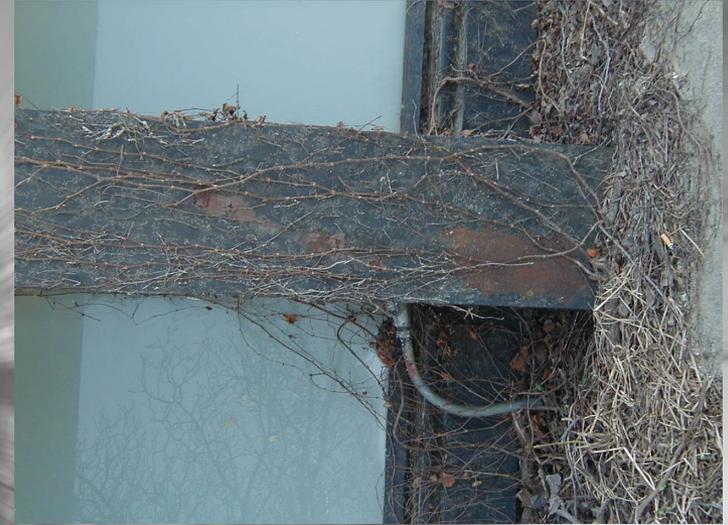
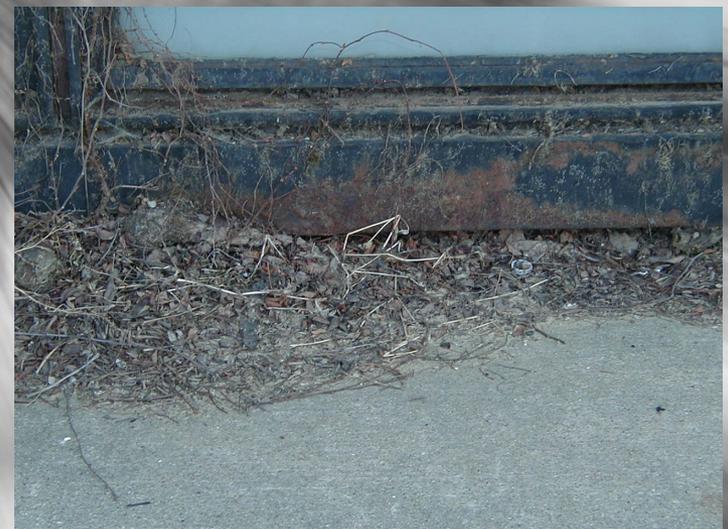
- Devise a plan to restore the exterior structural steel of Crown Hall
- Major problem with the exterior steel was that it was not maintained properly.
- it should have been cleaned, repainted, and had any exterior rust removed off of it.
- rust on the steel is caused by moisture mostly do to weather conditions
- This rust causes the steel to expand and contract, which in turn causes steel members to bow, which causes windows to crack.

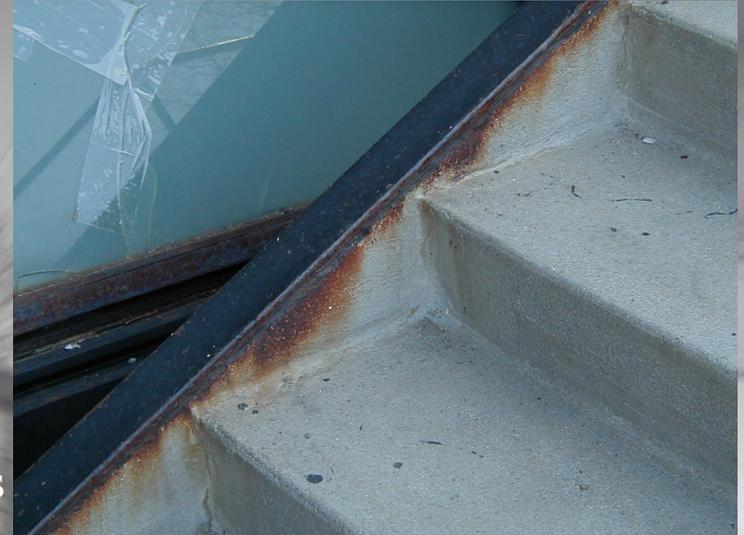
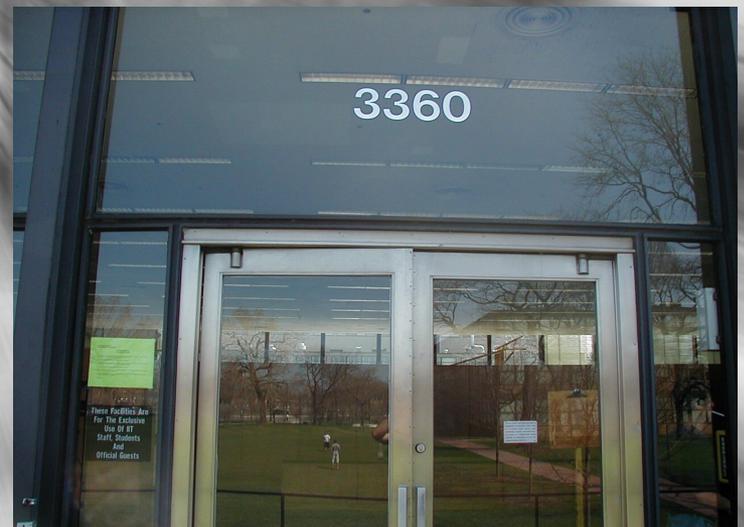
- If the problem is not dealt with, the overall structural soundness of the building could be affected negatively
- In these pictures, you can see the rust on the steel and how it is reducing the section modulus of the members.
- You can also see the member above the door frame and how it is bowed.

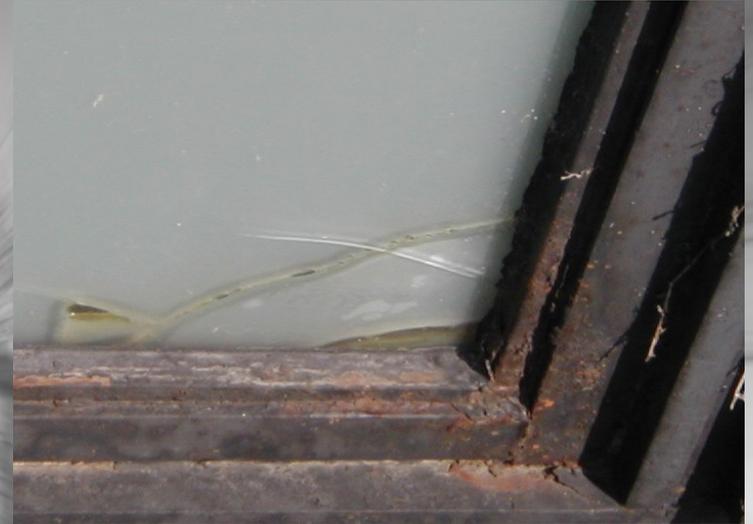
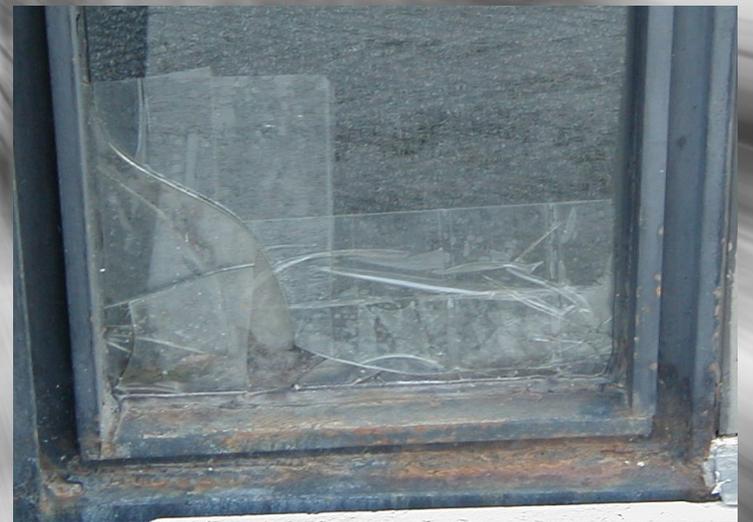
- The window frame contains a 5/16” piece of glass.
- To insulate the building a double paned glass was considered, but could not be installed because it is a landmark building.
- A landmark building cannot change any profile of the building. Eg. shape of window frame.
- A lot of windows have cracked because of problems with the outside steel rusting and expanding.

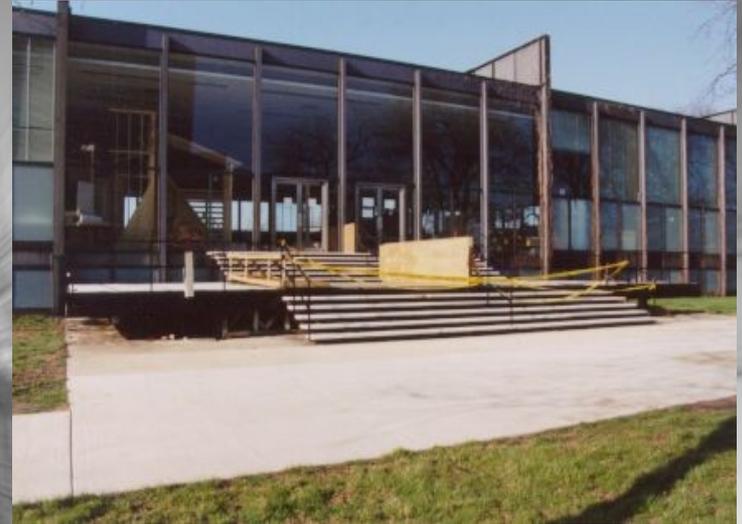
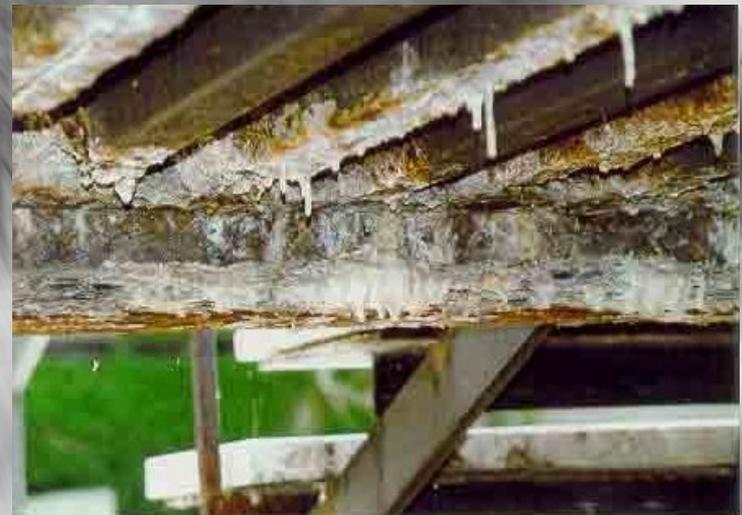
- Terrace is an exposed steel structure with a concrete slab on a corrugated metal deck covered by travertine pavers.
- The steel deck was rusted in 1997 and shows a significant amount of additional rust currently.
- The extent of corrosion indicates that the waterproof membrane has been compromised in several areas.
- The concrete slab and metal deck are unsalvageable. The steel and concrete will have to be replaced.

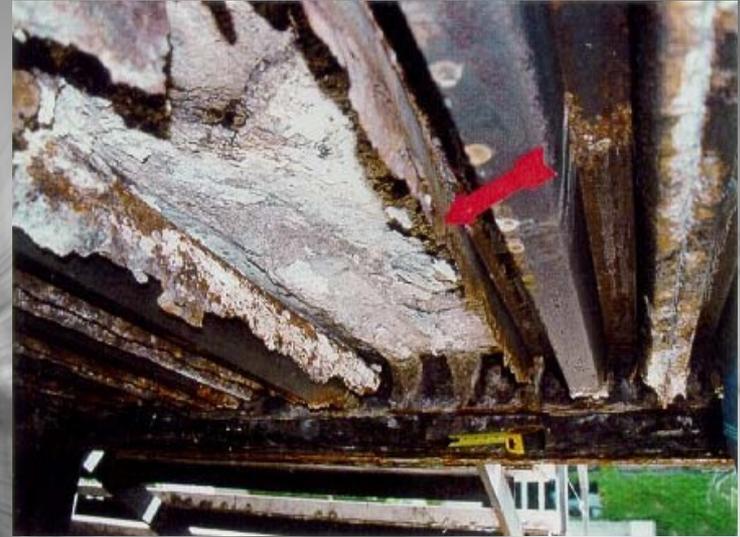
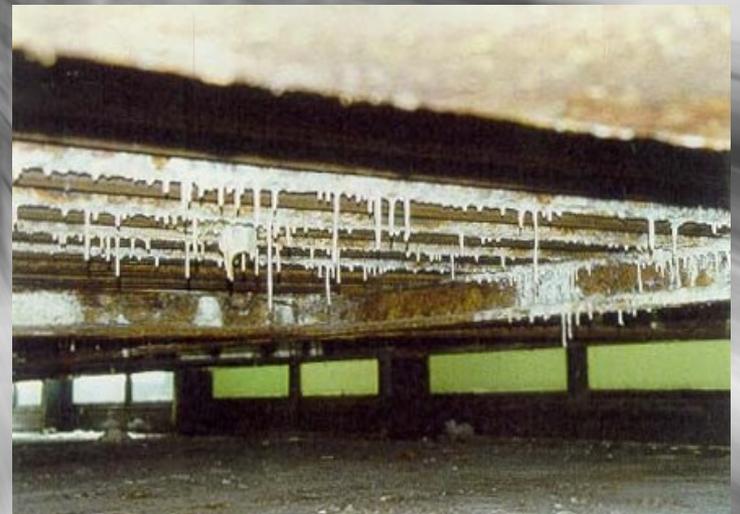
- Drains on the south entrance were found to be either clogged or only partially opened. Since the situation has worsened, more pieces of decaying concrete, steel, stone and Calcite deposits are blocking the drainage system. Some of the drains are even no longer attached.
- Due to the extreme decay of the concrete and metal structure, our representative from Scecnak Assoc. has suggested that a new system be designed
- Some of the railings around the deck have had their welds broken and need to be cleaned, painted and re-welded to the structure.
- Immediate action should be taken to preserve this landmark before it promotes further damage.

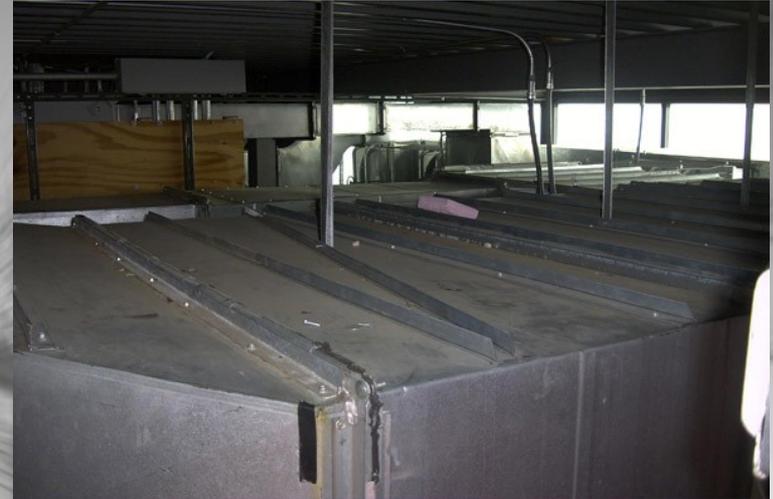
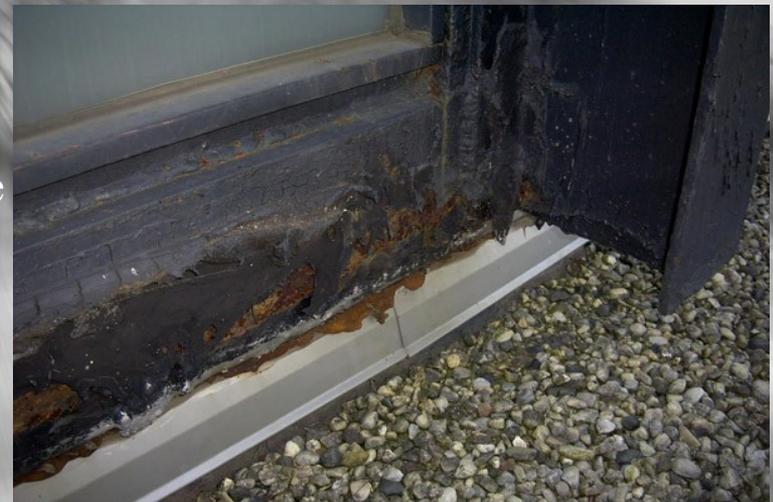
- Penthouse
 - This houses a majority of the mechanical equipment for the building. However, as a structure it is built in the exact same manner as the rest of Crown, which means that structurally it is suffering from the same problems.
 - Both the primary steel beams of the roof as well as the smaller window mullions are severely rusted.
 - They also have vines that have embedded themselves into the steel furthering the damage every year.
 - The solutions for this are the same as those for the exterior steel of Crown Hall.

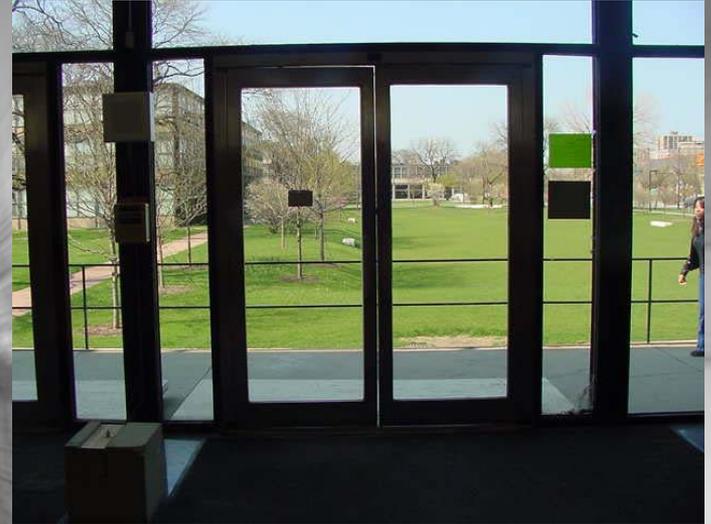
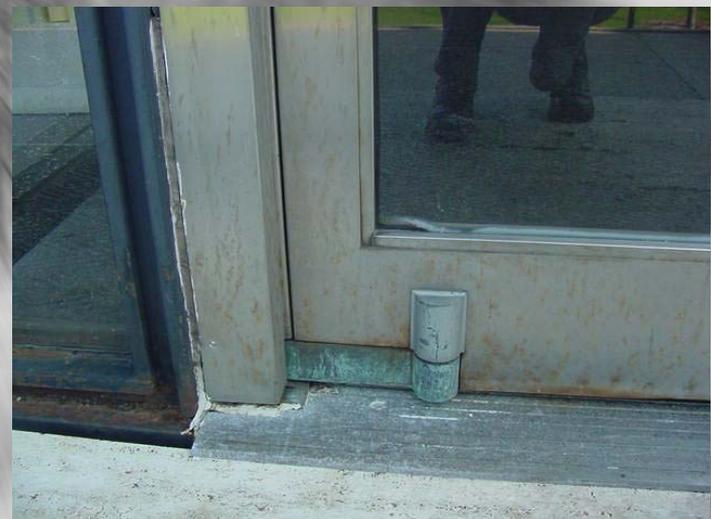
- North entry doors
 - They consist of a stainless steel frame with a glass light and balanced door hardware.
 - The doors have wracked (twisted) over the last 50 years.
 - They are not correctly fitting into their frames.
 - The hardware has also worn down over time.
 - The frames, doors, and hardware can all be recreated exactly as they were originally made, as the Northcamp Company has the original shop drawings.
 - A total of four pairs of doors would be needed.

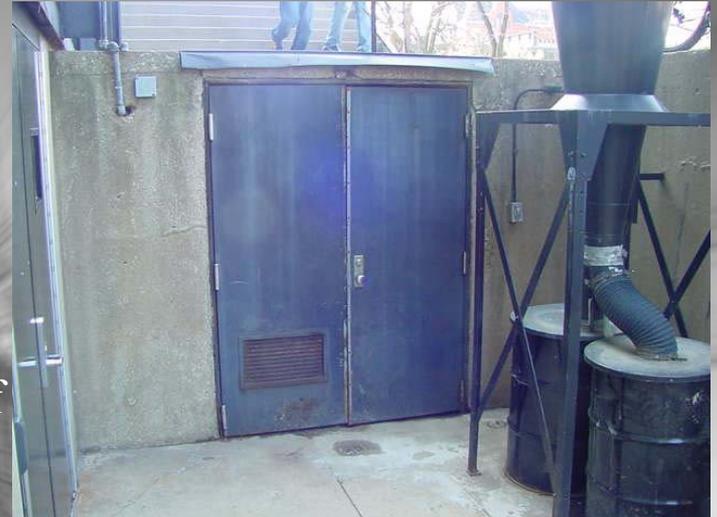
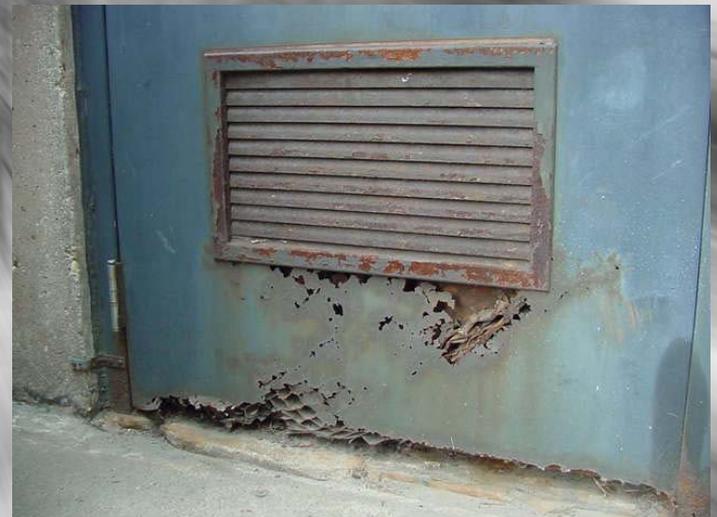
- Lower exterior mechanical room doors
 - Under the north porch is a mechanical room accessed by steel doors at the bottom of the east and west entry stairways.
 - On the east side of the building is a double set of doors and on the west side is a single door.
 - Both sides have louvered vents at the bottom.
 - All three of these doors have severe rust problems and should be replaced in order to provide security and weather protection for the mechanical equipment inside.

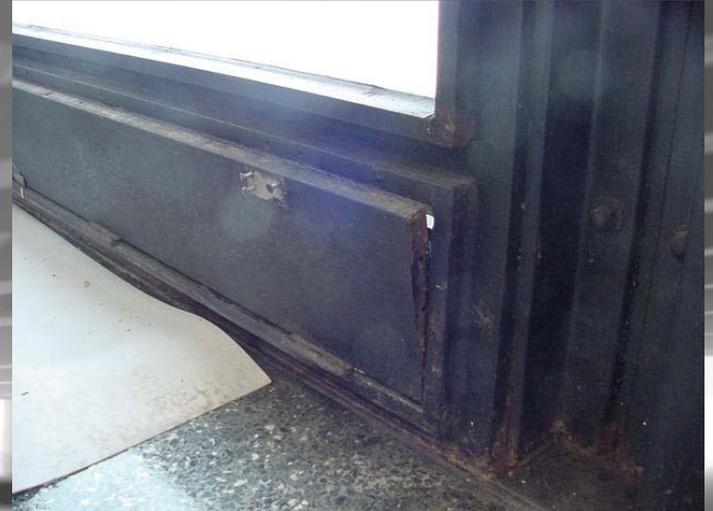
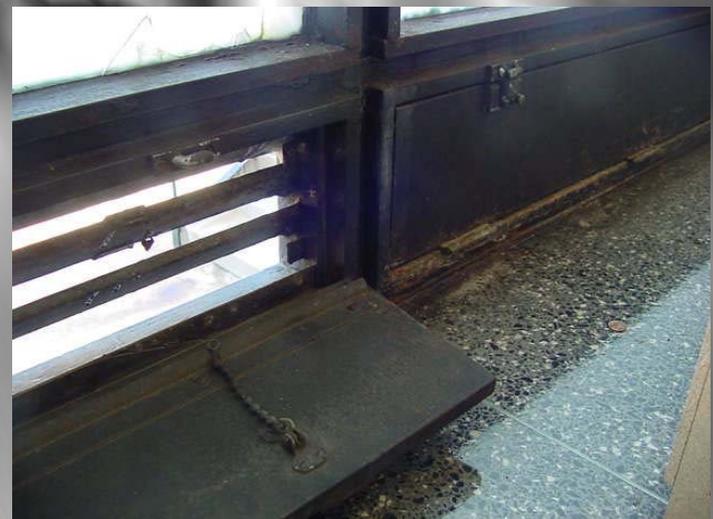
- Louvered vents
 - Under each window around the exterior of the building on the upper level is a louvered vent.
 - There is a plywood panel that hinges open and locks with latches.
 - The hardware on many of these vents is rusted and/or non-functional due to broken latches or hinges.
 - The hardware on all of the vents should be replaced, and the vents and covers should be cleaned and repainted.
 - There is also a problem with ivy growing inside the building through the vents, and the ivy should be removed.

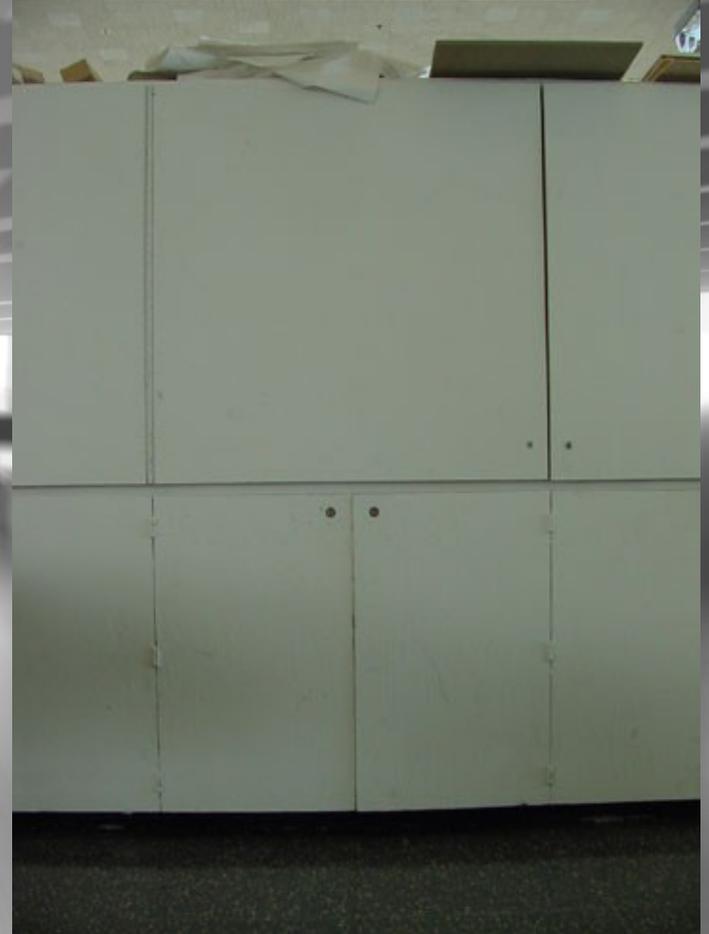
- Lockers
 - Made of seven-ply exterior-grade plywood
 - Generally in good condition
 - Surfaces to be stripped and fill
 - Alkyd enamel to be applied
 - Repair/replace lock sets

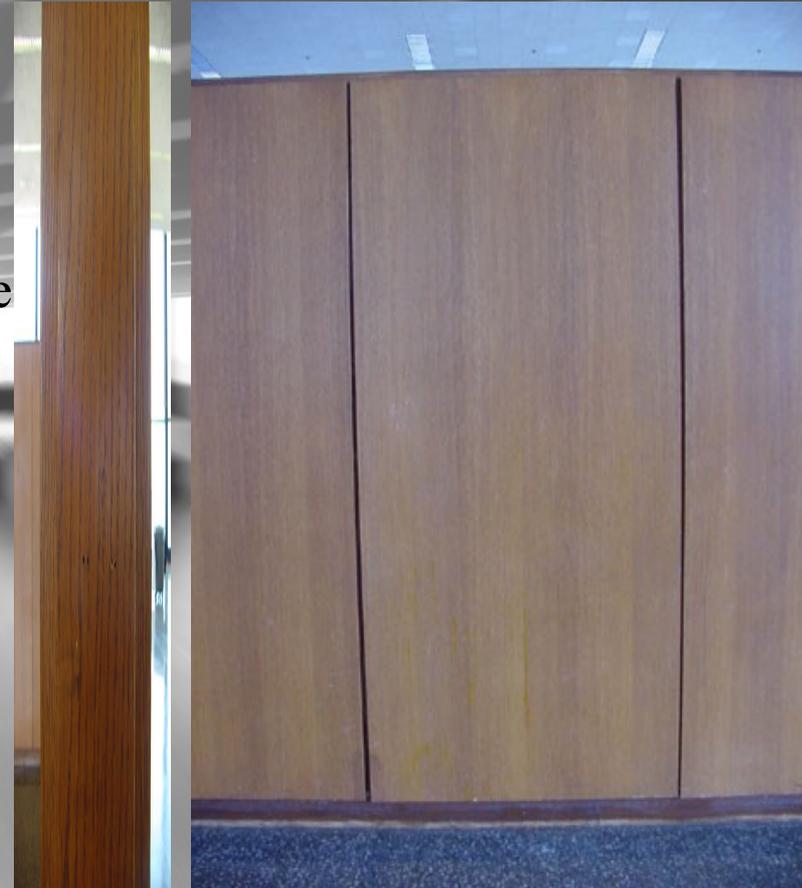
- Wood Panels
 - Made of seven-ply Spruce Plywood
 - Surfaced with 1/4" White Oak veneer
 - Veneer too thin to be sanded and refinished
 - Two options for restoration: apply new veneer or replace panels entirely
 - Decision will be based on price
