## **Interprofessional Project**

**I PRO 301  
Solar Hydrogen Hybrid System  
Fall 2004  
Final Report**

**December 3, 2004**

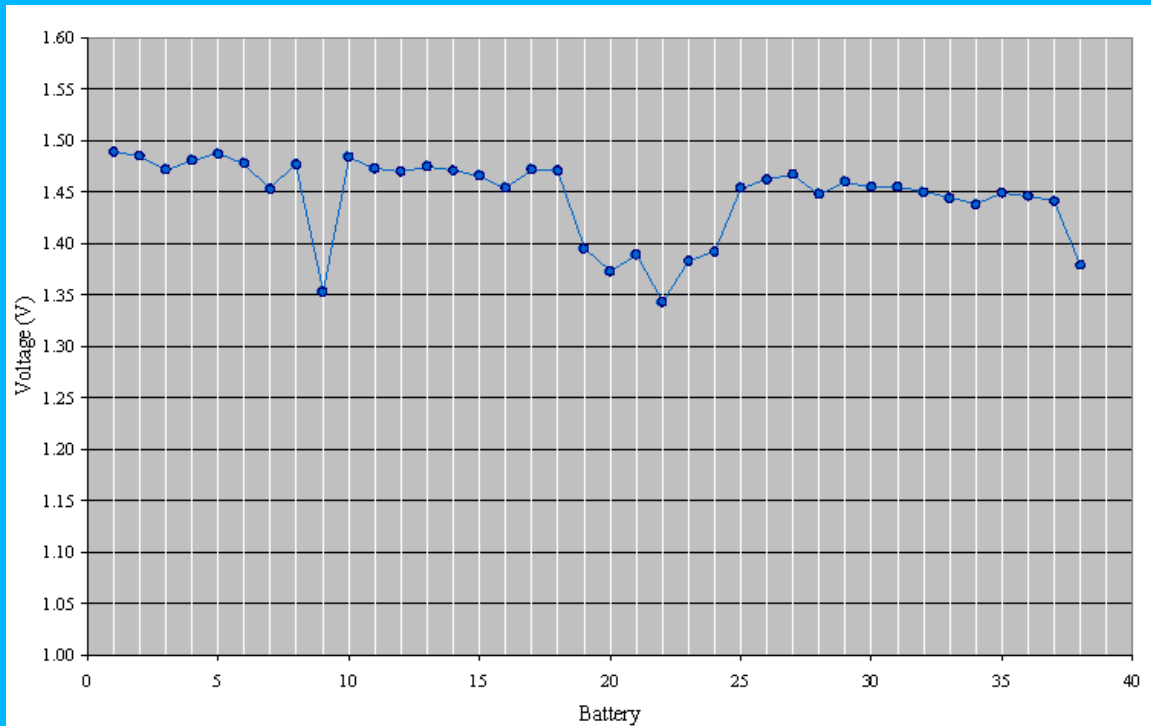
Figure 2: Battery voltage after a week of charging.

The batteries require an electrolyte to provide ions and water for the chemical reaction that produces power. Typically, the electrolyte does not need to be replaced, but the level was getting low in the batteries. Therefore, Brian suggested adding de-ionized water to ensure the batteries would not run dry. This task, as well as measuring individual battery voltages, was the first activity during the work day. A graph of the voltages can be seen in Figure 1. The majority of the cells charged to the proper levels, but there were a few cells that are below their full voltages even after a week of charging.

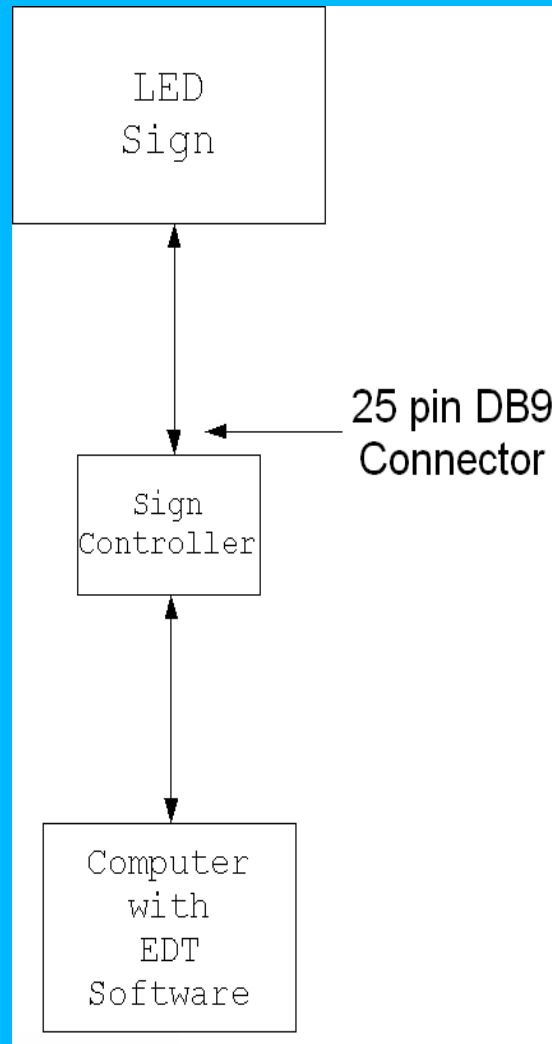
**Figure 3: Diagram of computer to sign connection.**

The third concern of the work day was the connection between the computer and the sign. When the sign was installed on the roof, the plug of the cord coming from the sign to connect it to the controller was cut off to allow running it through the conduit. Earlier in the semester, we had attached a plug to the cord and connected the sign directly to the computer. Brian was able to correct this mistake during the work day. The cord from the roof needed a plug that would connect it to the controller box. The black box takes the information entered into the EDT software, converts it into a format the sign can recognize, and tells the sign which LED's should light up to display the desired message. From this box another cord runs to the computer. The end of the work day was spent attaching metal pins to the twenty-five wires in the cut cord. Unfortunately, we could not find any documentation that said what order the pinned wires should be installed in the plug.

Brian said he had a cable that had connected the sign to the controller when the sign was from earlier in the project. After tracking down and locating this cable a few days later, we were finally able to attach the sign to the controller and the controller to the computer. A message was programmed, and the software was able to communicate with the sign. The sign even lit up; however, it did not display the programmed message. The companies that made the sign and the software have both been sold or gone out of business since the equipment was purchased, and so cannot offer any technical support. Technically, the sign works, in that it receives communication from the computer and displays data. The data it displays, however, is not the desired data.
