Mundelein Center

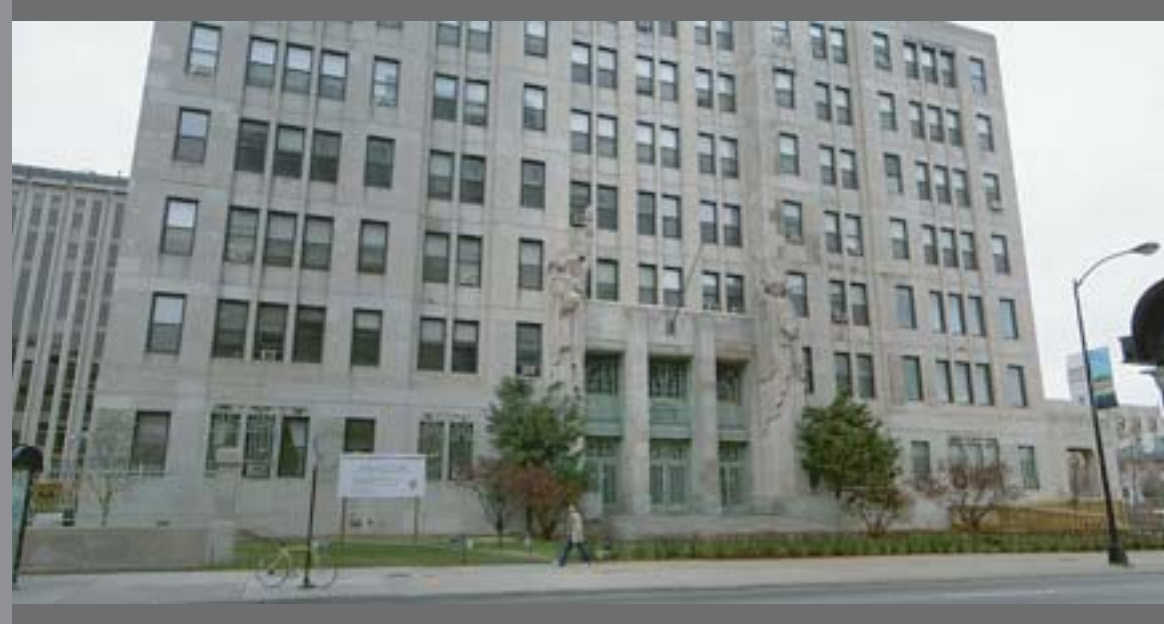
Thermal Images displaying the majority of the heat loss through windows which will be replaced as well as the foundation walls.

Mundelein Center was built in 1928. It was built in authentic art deco architecture. Made of stone this building, has severe HVAC problems as well as outdated electrical and plumbing infrastructures, which are currently in the process of being updated.

The R-value was calculated to be **2.5 ft²/(°F)* (hours/BTU)**.

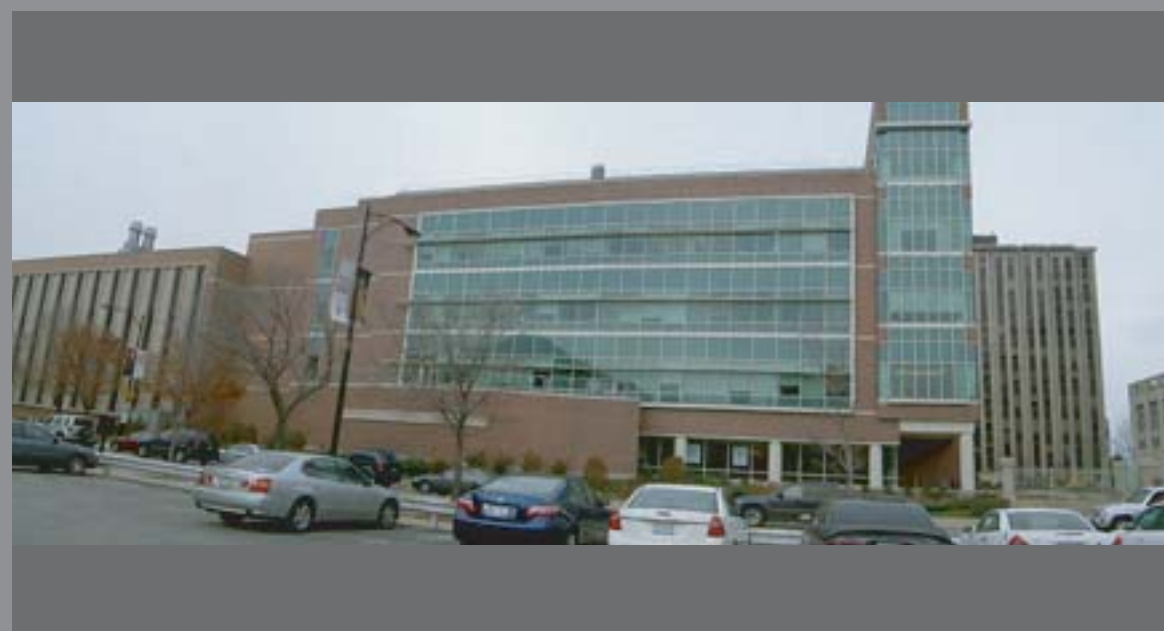
Thermal Images displaying the majority of heat loss through the windows and the difference in temperature where there was a double glazing system.

Quinlan Life & Science Center is one of the newest buildings on campus finished in 2004. It is made from concrete and masonry. There are five floors which total square feet. This is the schools biology department.

The R-value was calculated to be **20 ft²/(°F)* (hours/BTU)**.

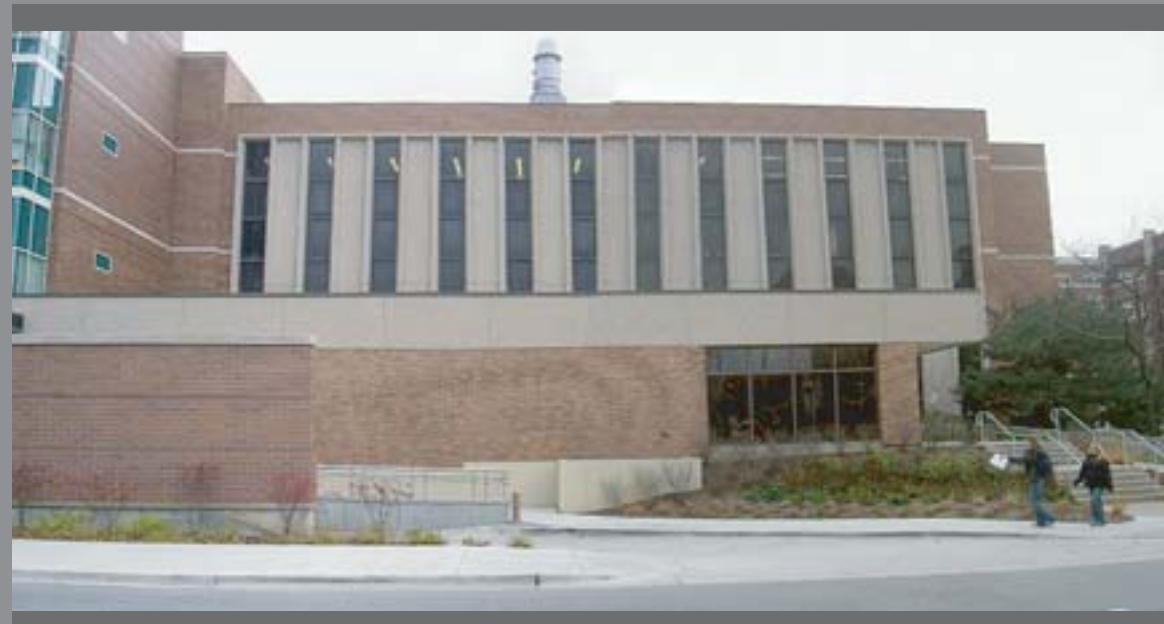
Thermal Images displaying the majority of the heat loss the foundation walls of the building, due to the fact that there is only a small percentage glazing.

Flanner Hall was built in 1976. It is undergoing a complete interior renovation dealing with furniture as well as electrical equipment. No renovations have been done to the building since it had been built. The function of the building is mainly laboratories therefore the HVAC system is very important.

The R-value was calculated to be **3 ft²/(°F)* (hours/BTU)**.

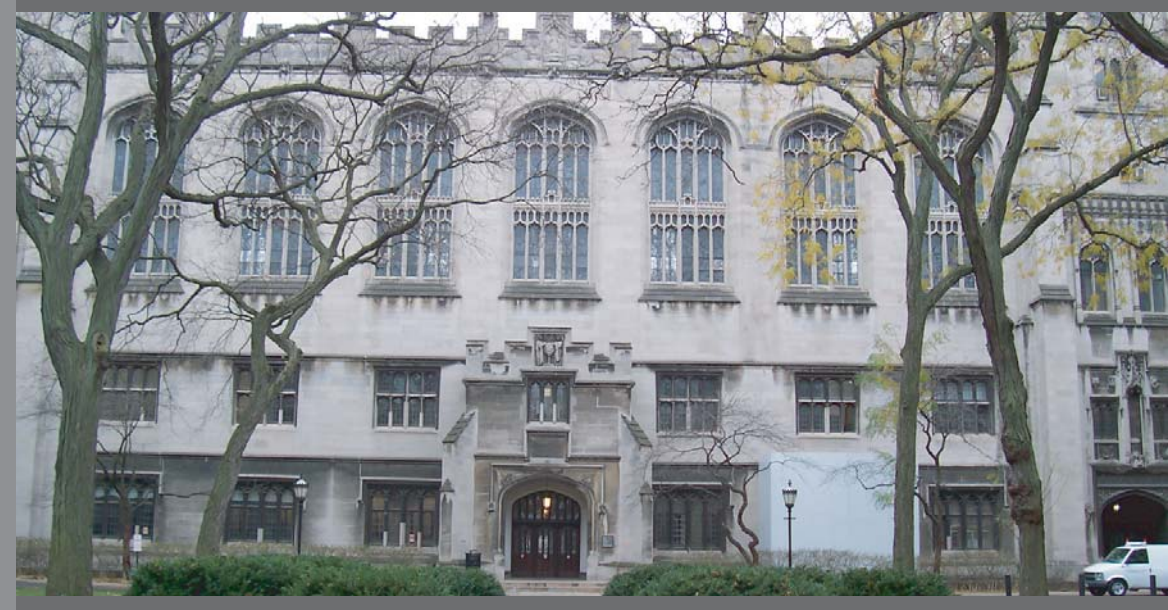
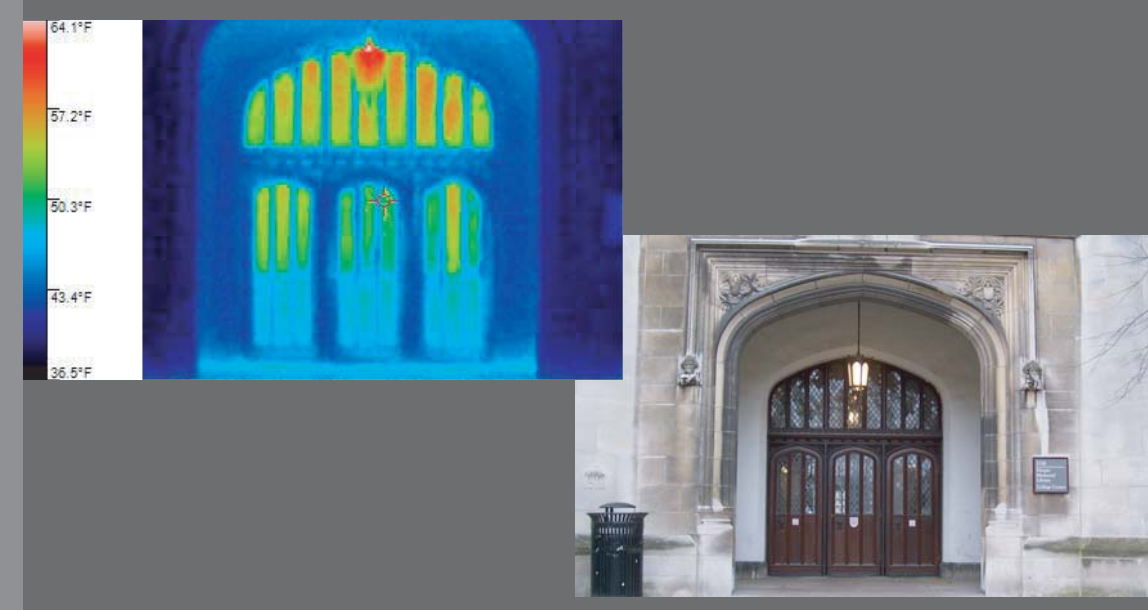
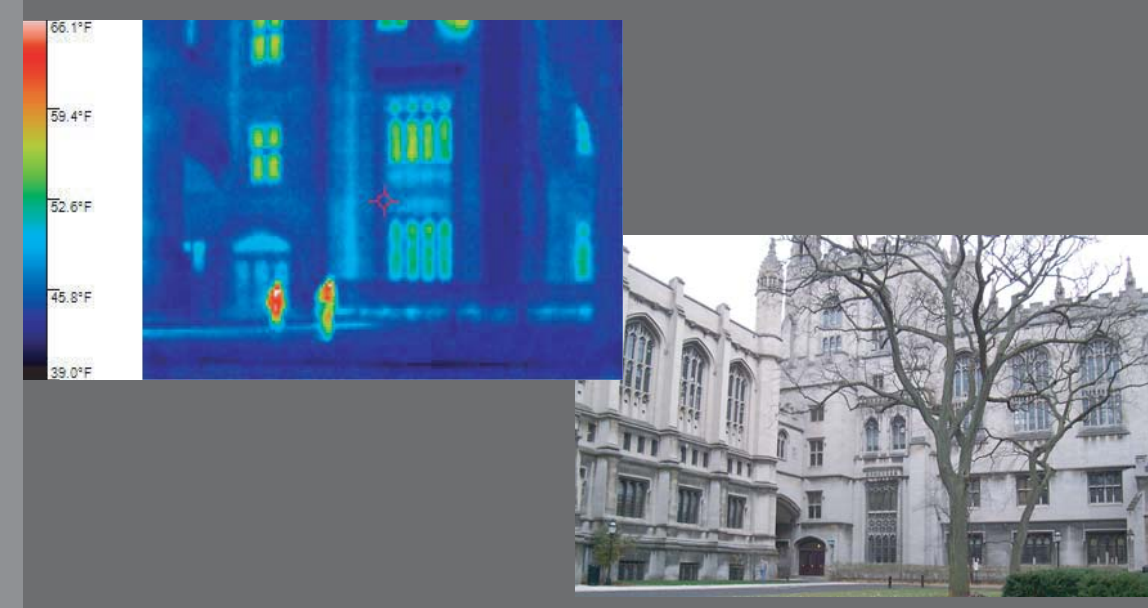
Thermal Images displaying the majority of the heat loss through windows and door entrance of the building.

Harper Library was built in 1910. It is a gothic building located on the U of C quadrangles. It is made of brick, limestone, and leaded glass windows. It is 114,318 square feet.

The R-value was calculated to be $5.27 \text{ ft}^2/(\text{°F}) \cdot (\text{hours}/\text{BTU})$.

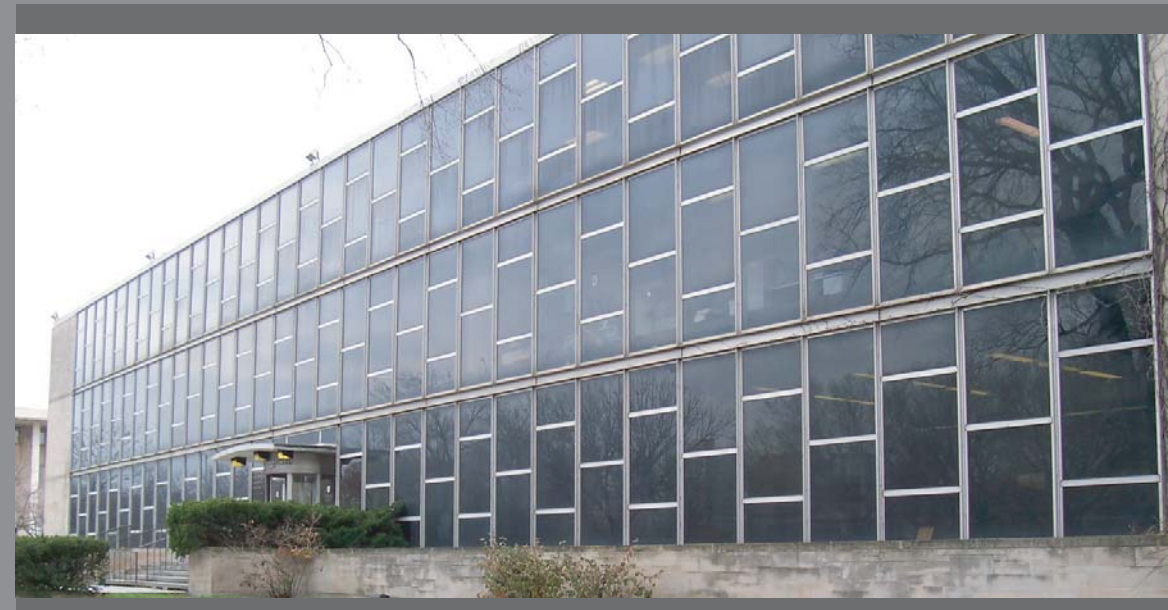
Thermal Images displaying the majority of the heat loss through the curtain wall of the building.

Charles Stewart Mott Building was built in 1958 by Schmidt, Garden, and Erikson. It is a glass and concrete building with 36,072 square feet. It houses administration offices on three floors. The university has encountered the most heating and cooling problems with this building than any other on campus.

The R-value was calculated to be $1.1 \text{ ft}^2/(\text{°F}) \cdot (\text{hours}/\text{BTU})$.

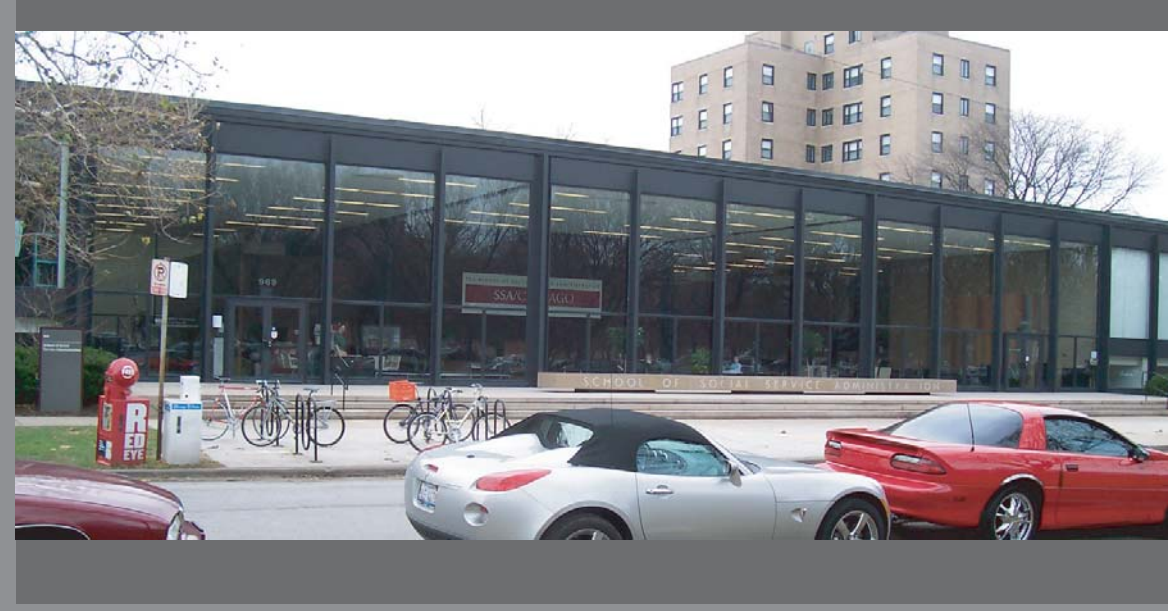
Thermal Images displaying the majority of the heat loss through windows as well as the door entrance.

The School of Social Service Administration (SSA) was built in 1964 by Ludwig Mies Van Der Rohe. It is a steel and glass building with 52,007 square feet with one story. It

The R-value was calculated to be $1.48 \text{ ft}^2/(\text{°F}) \cdot (\text{hours}/\text{BTU})$.
