# **I PRO 304:**

## **Integration of Process Improvements**

Sponsor: A. Finkl and Sons (Chicago, IL)

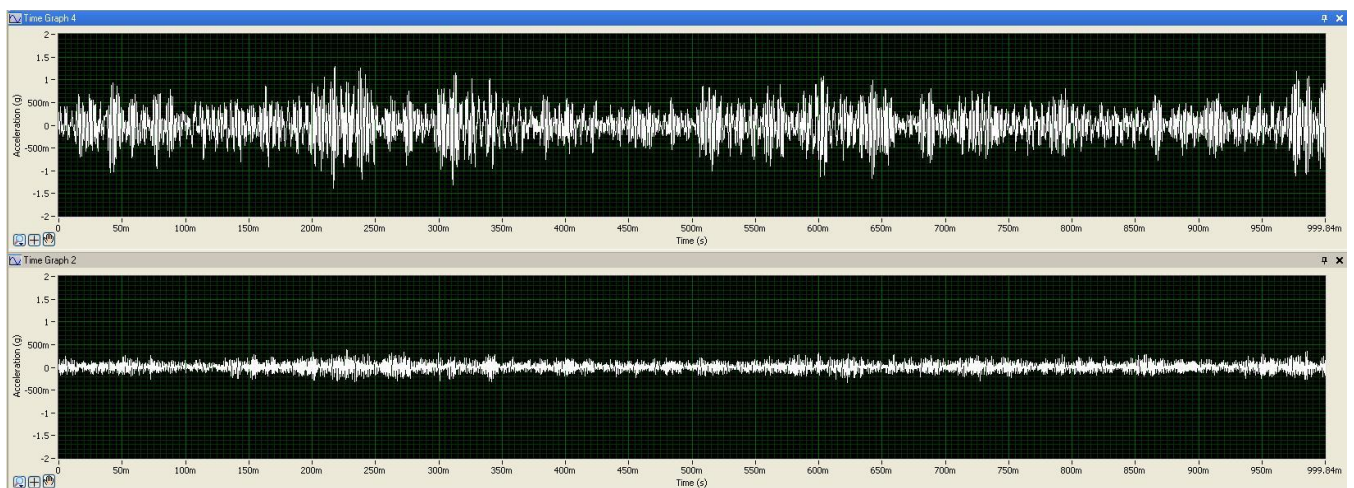
Proximity of the accelerometer (on the material) and where the mill was cutting caused amplitudes to be larger when the mill was cutting closer to the accelerometer and amplitudes to be smaller when cutting farther away from the material.

Figure 4 Proximity of Accelerometer to Cutting Location

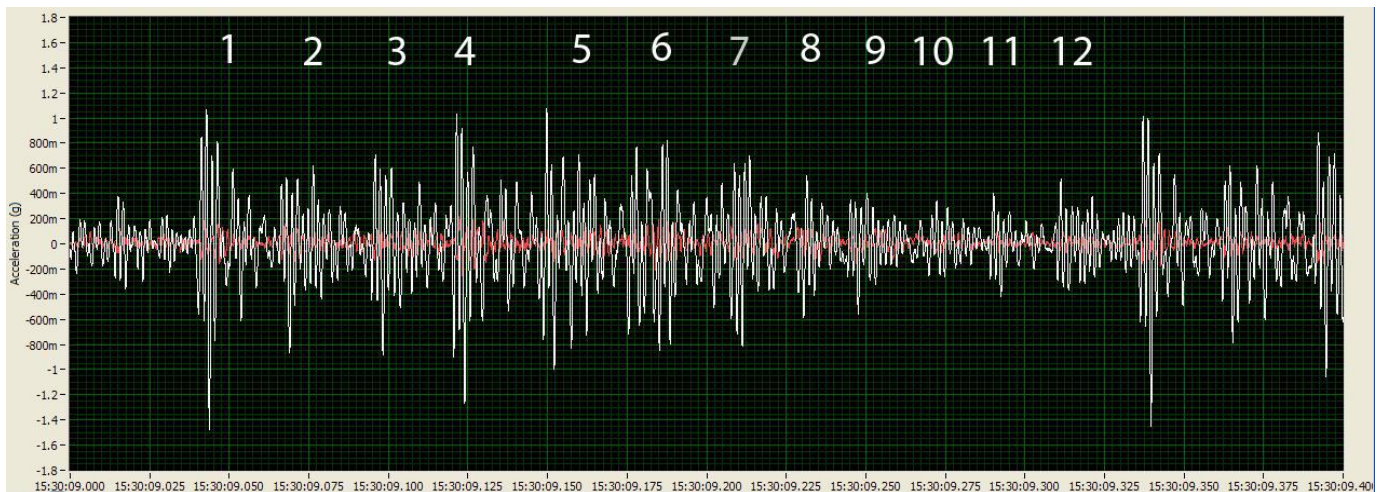
It was noticed that we can see inserts making contact with the material. Through the accelerometer readings, we can see spikes at precisely the same interval as the time between one insert making contact with the material and the next insert making contact. If all the inserts were uniformly worn, it became difficult to determine where a insert contact was made. However if a insert was not uniformly worn like the rest of the inserts it would cause an increase in amplitude for the insert that is next to make contact. This is due to the broken insert making less contact with the material, and the insert following it to pick up the job of cutting the extra material.

It is very helpful to be able to see individual inserts and their impact results with the material. The accelerometers take the data in real time and are able to analyze and record each insert and its history. It is important to note we were able to view inserts hitting from the material and

Figure 7 Individual Inserts Shown during 1 Revolution

- 1) There is a regular, observable interval where each insert makes contact with the metal. This contact time is seen as a spike in the time domain readings of the accelerometer
- 2) The amplitude of these spikes apparently depends on feed rate, rpm, and the depth of the cut.
- 3) Upon adding broken inserts, it is possible to observe two things. First, there is a clear difference in the PSD of the accelerometer readings when inserts are broken. Second, the amplitude of the spikes caused by the broken inserts in the time domain is noticeably different from that of the frequency domain. This, therefore, allows us to note when cutting inserts fail.

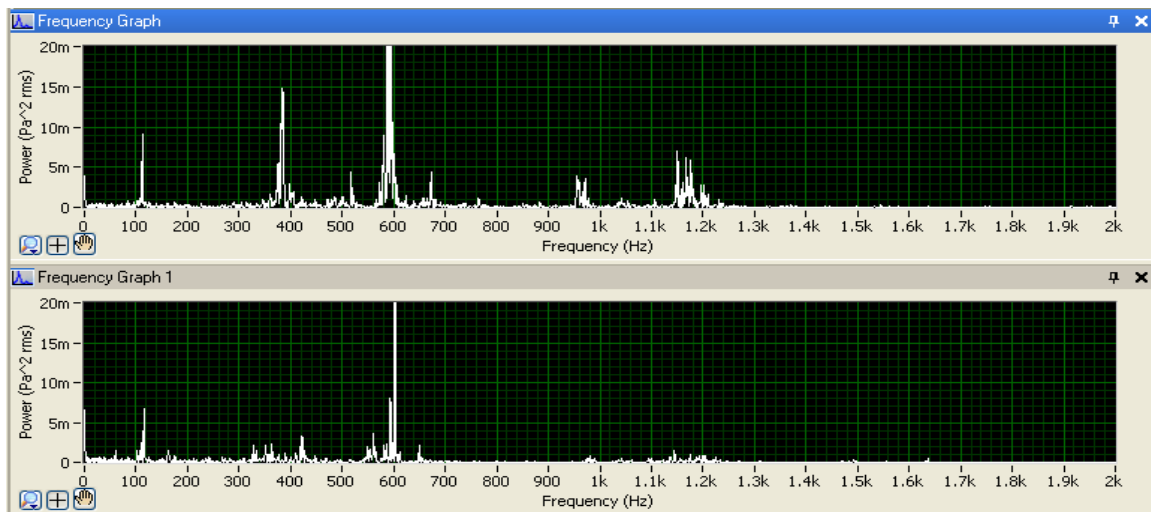
Figure 10 Microphone Frequency of 3 broken inserts and 0 broken inserts (125RPM)

From the graphs show above, there are some frequency components exist in every run. They spread from about 300 Hz to 700 Hz, with a peak at 600 Hz or sometimes at 300 Hz. These frequency components are from the sound created by the machine, not from the cutting. They are so powerful that they have might actually hide some information from the cutting process in this frequency range.

Despite of the confusion from the machine sound, by comparing the signal of a 3 broken inserts run and a 0 broken inserts run, there is still some useful information can be found. They are show in the table below.

Unfortunately, we cannot draw any concrete conclusion from these differences because they are not strong enough to indicate the detection of broken inserts. More work needs to be done to separate the sound created by the cutting from the noise sources, like vibration sound from the machine, human voice and ambient noise.

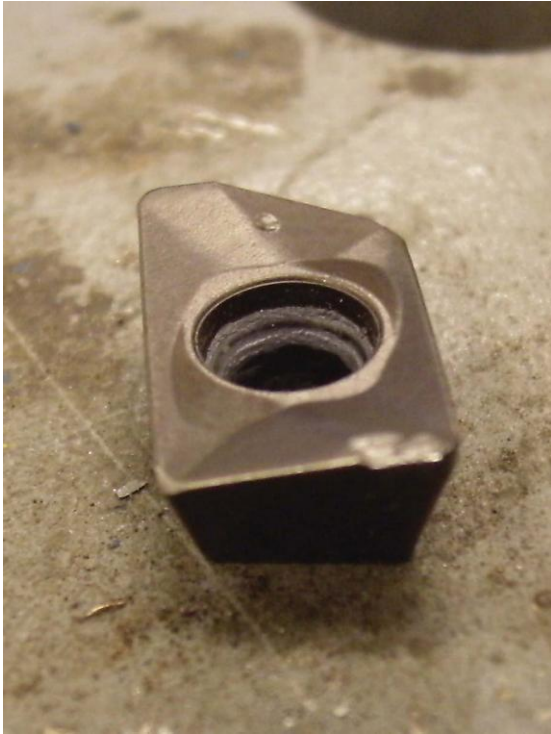
Figure 13 Broken Carbide Insert

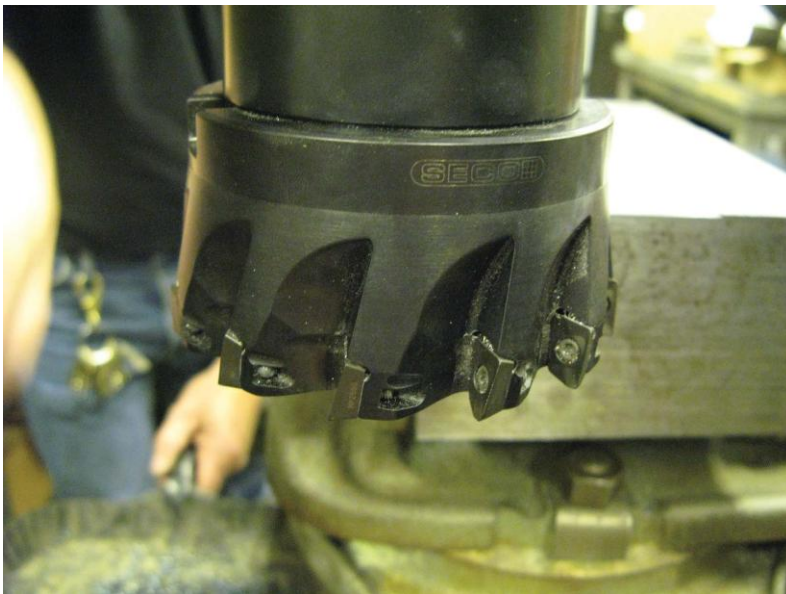
Figure 14 6" diameter milling cutter on IIT's manual milling machine

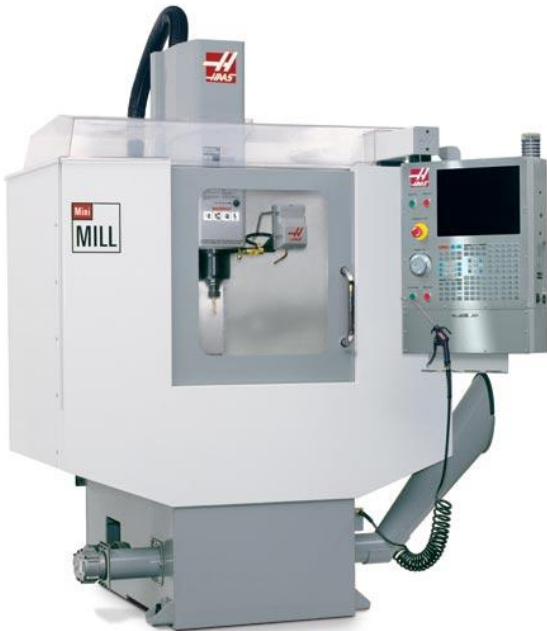
Figure 16 Haas CNC Milling Machine

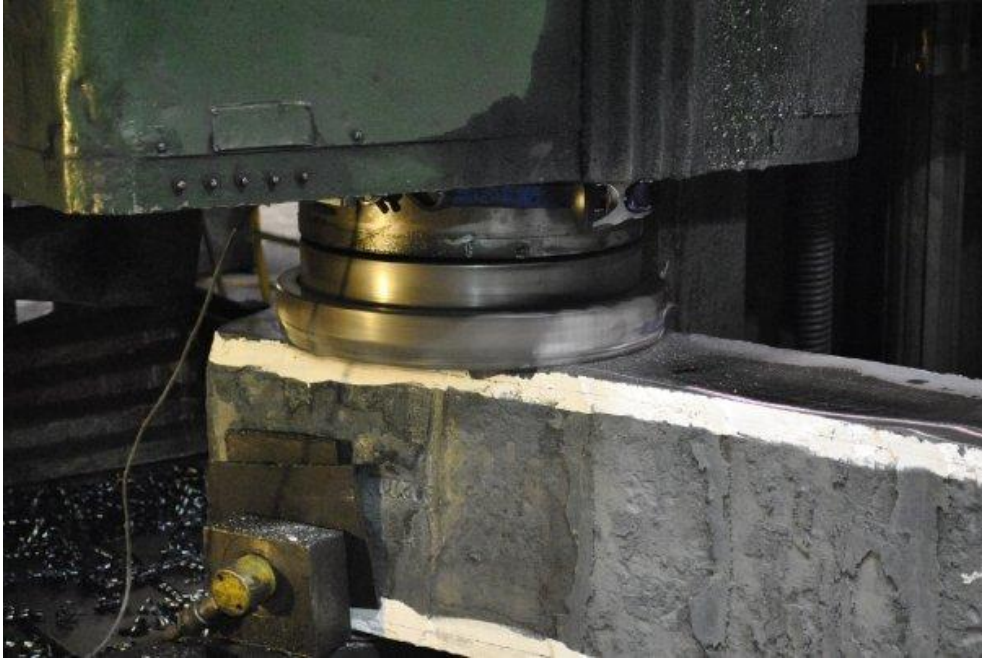
Figure 17 A Finkl & Sons' Vertical Spindle Milling Machine

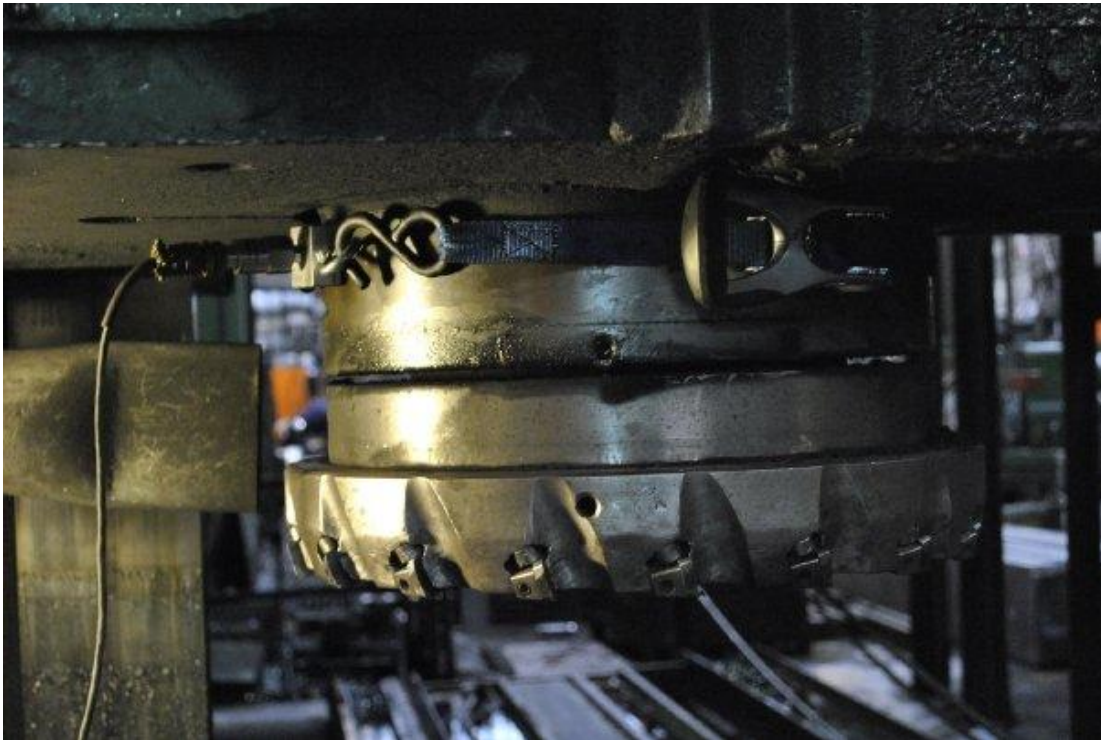
Figure 18 Custom made mounting for accelerometer on A Finkl & Sons' milling machine

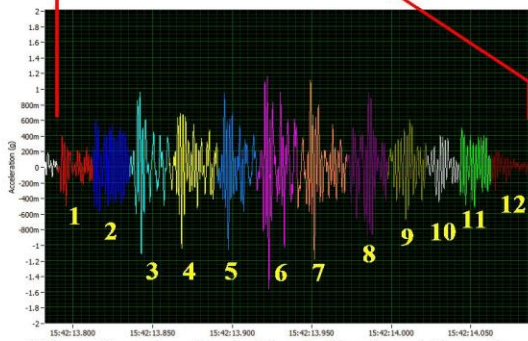
Figure 19

Above: View From 1 Run

Above: View Showing Each Tooth During 1 Rotation  
CNC Machine - 0 Broken Inserts

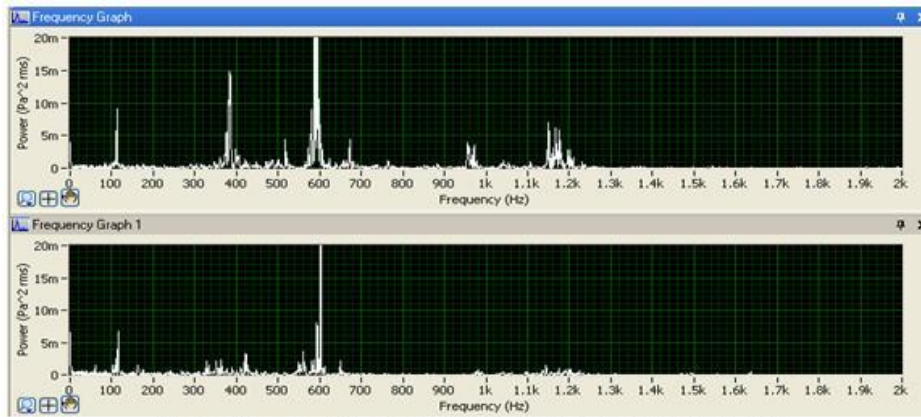
Figure 22

Comparison of 3 broken teeth and 0 broken teeth (125RPM)
