# **I PRO 304**

## **Integration of Process Improvements**

Spring 2010

Sponsor: A. Finkl & Sons (Chicago, IL)

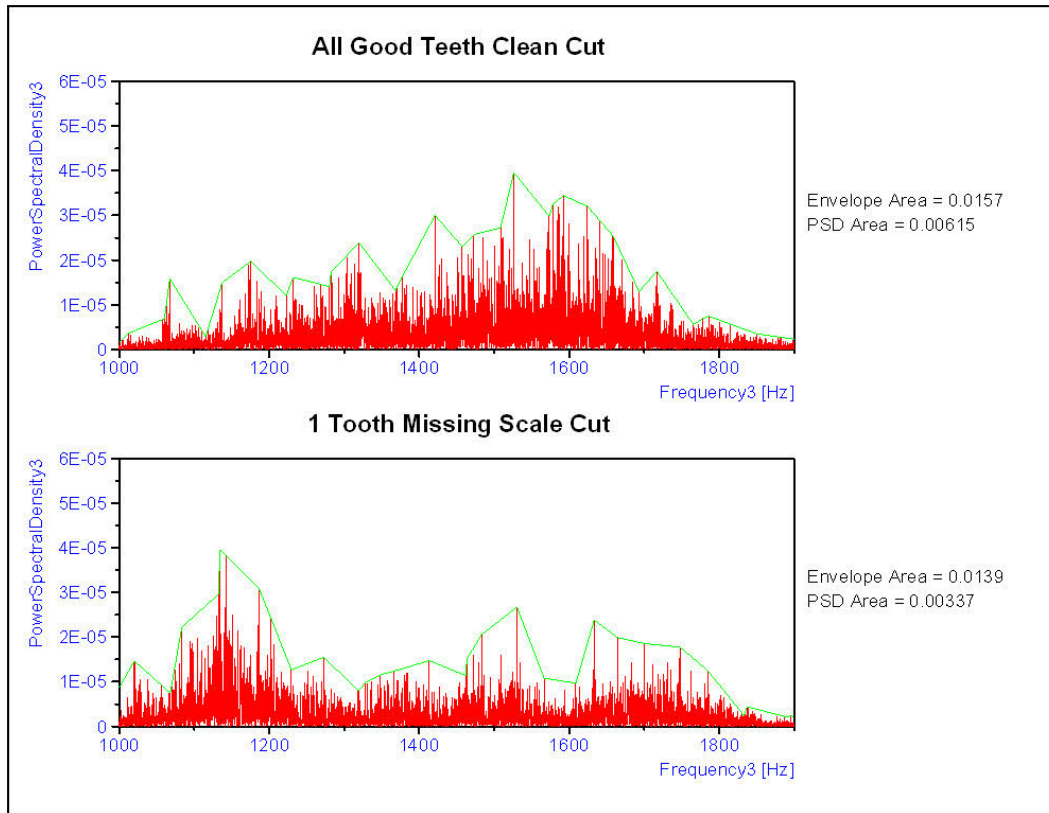
In other cases, it was noticed that the frequencies would shift positions and/or certain frequencies would drop out entirely leading to a thinning of the PSD, as seen here:

In the first case (of a drop in PSD with missing inserts), breakage detection can simply be accomplished by integrating the area under the PSD curve (whether by enveloping the peaks and integrating the envelope or directly integrating the PSD) and looking for a drop in PSD area above a certain threshold. In the third case (of a thinning of the PSD frequency spectrum), a direct integration of the PSD curve (not of an envelope) along the frequency domain will yield a comparison point for breakage detection, because even though the magnitudes of the PSD do not drop the curve thins out and yields a drop in the area under the curve. For the second case (of a frequency shift), integration yields no breakage condition, so some other method would need to be established to identify the proper shifts related to a breakage. To determine which PSD change predominates, controlled testing will need to be completed onsite at the Finkl production mills. This onsite testing will allow this IPRO to identify which condition(s) usually occur at Finkl, and exactly what threshold changes occur when an insert breaks. The work of this semester proved the usefulness of PSD analysis in detecting these breakages on a laboratory CNC milling machine, and showed that the first condition (of a drop in PSD) predominates on the CNC machine.

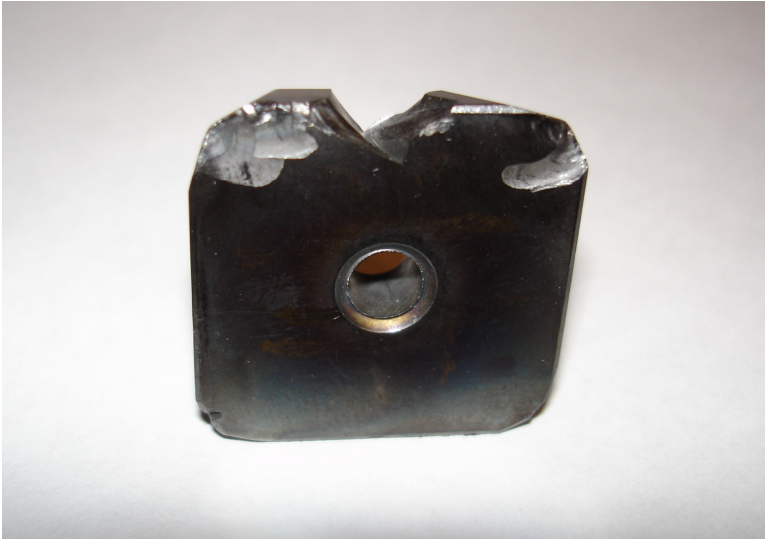
**Figure 1.** Broken Cutting Insert

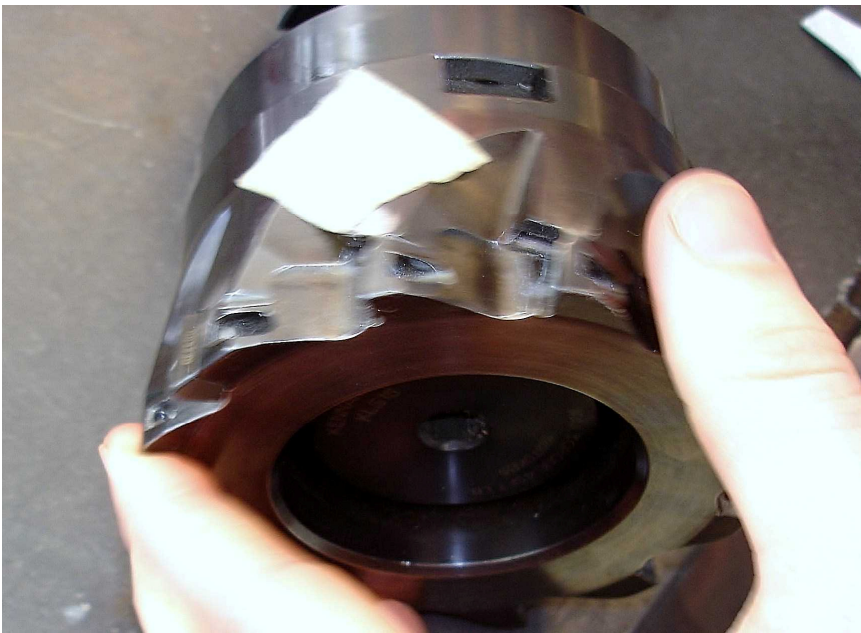
**Figure 2.** A milling head from the HAAS CNC machine at IIT.

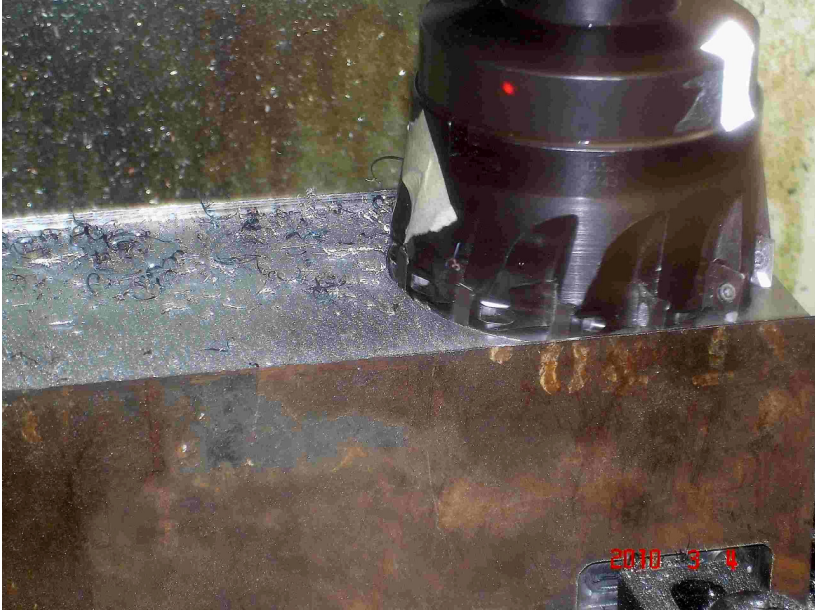
**Figure 3.** HAAS CNC machine

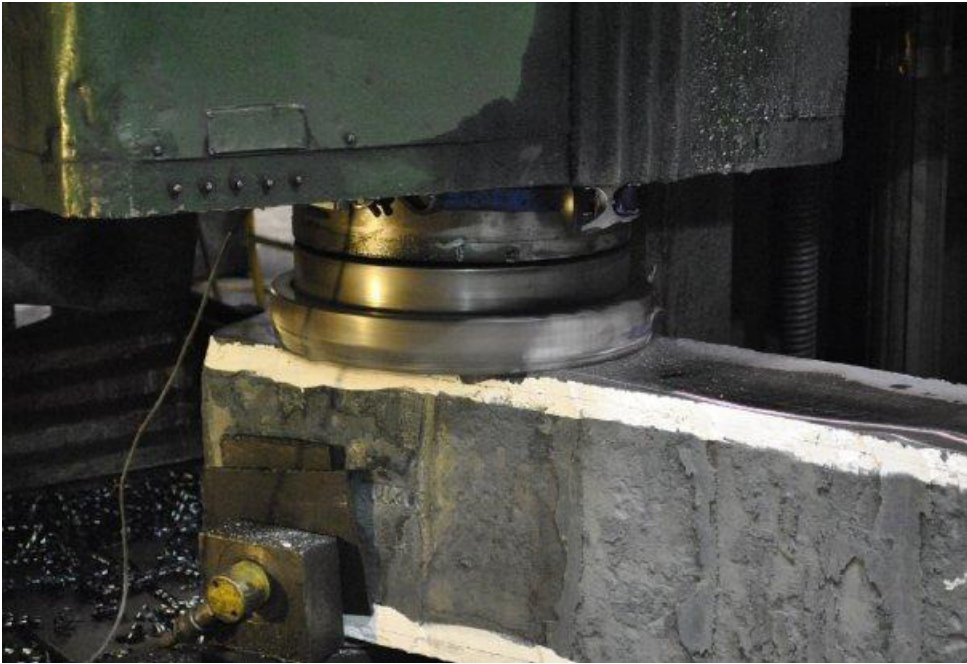
**Figure 4.** Finkl milling machine

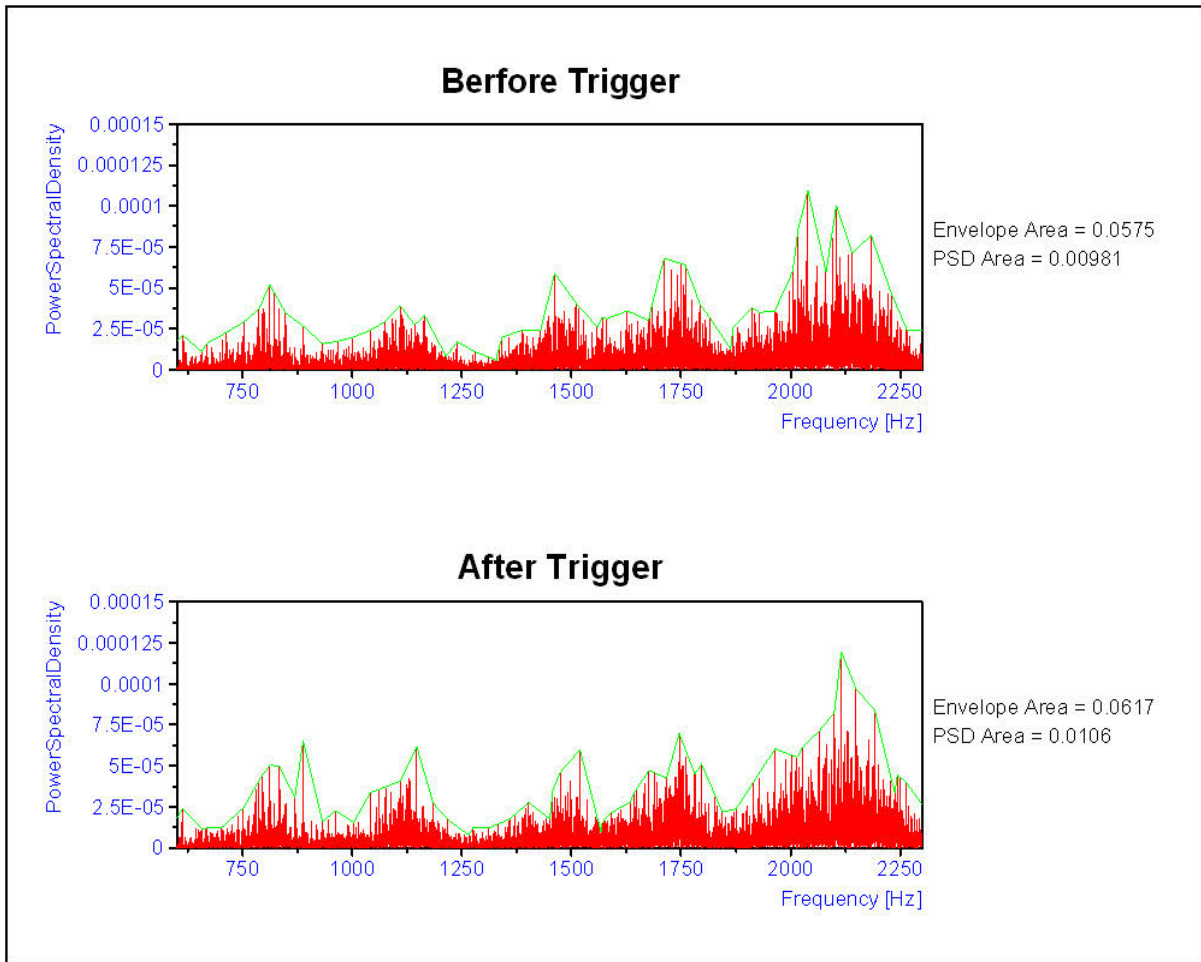
**Figure 6.** Shows the difference in received accelerometer data before and after a trigger is captured.
