# RESEARCH

## Existing Building Systems

Illinois Institute of Technology  
IPRO 311  
Fall 2009

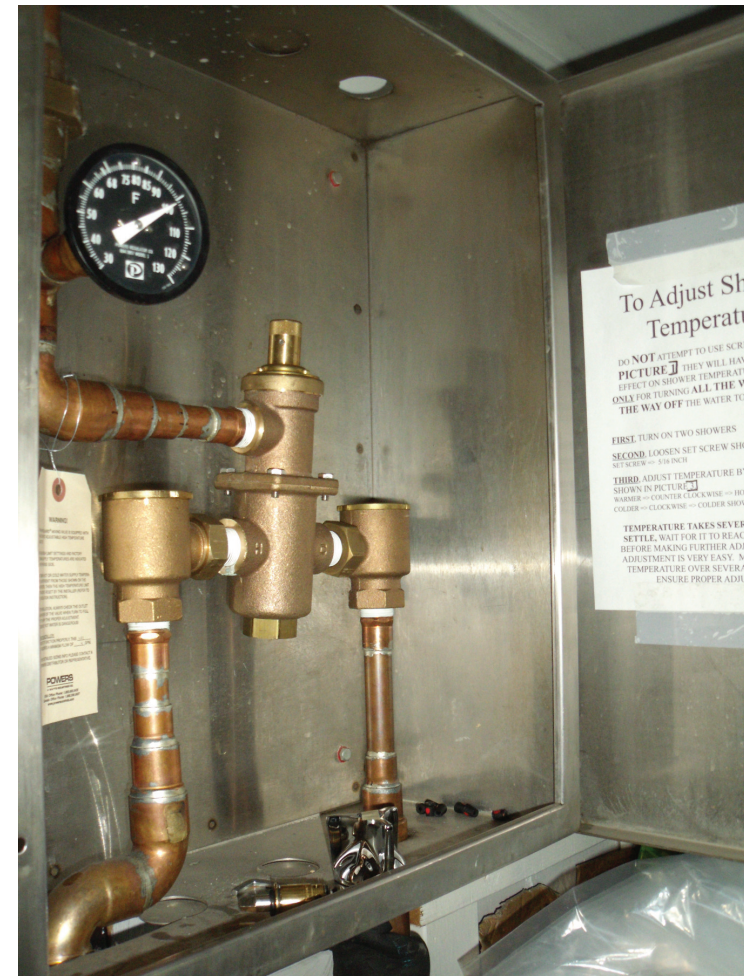
-Water closets operate at 3.5 gallons per flush--over double current plumbing standards

-Urinals meet code at 1.0 gallons per flush, but more efficient systems are available on the market and are reasonably easy to implement

-Showers have unreliable water pressure and no personal temperature controls

-Installation of dual-flush toilets would reduce water consumption by more than 50%

-Replace urinals with water-less varieties, which use zero water and require easy, routine maintenance

-Replace shower supply with adjustable temperature in order to comply with current expectations among students in dorm-living situations

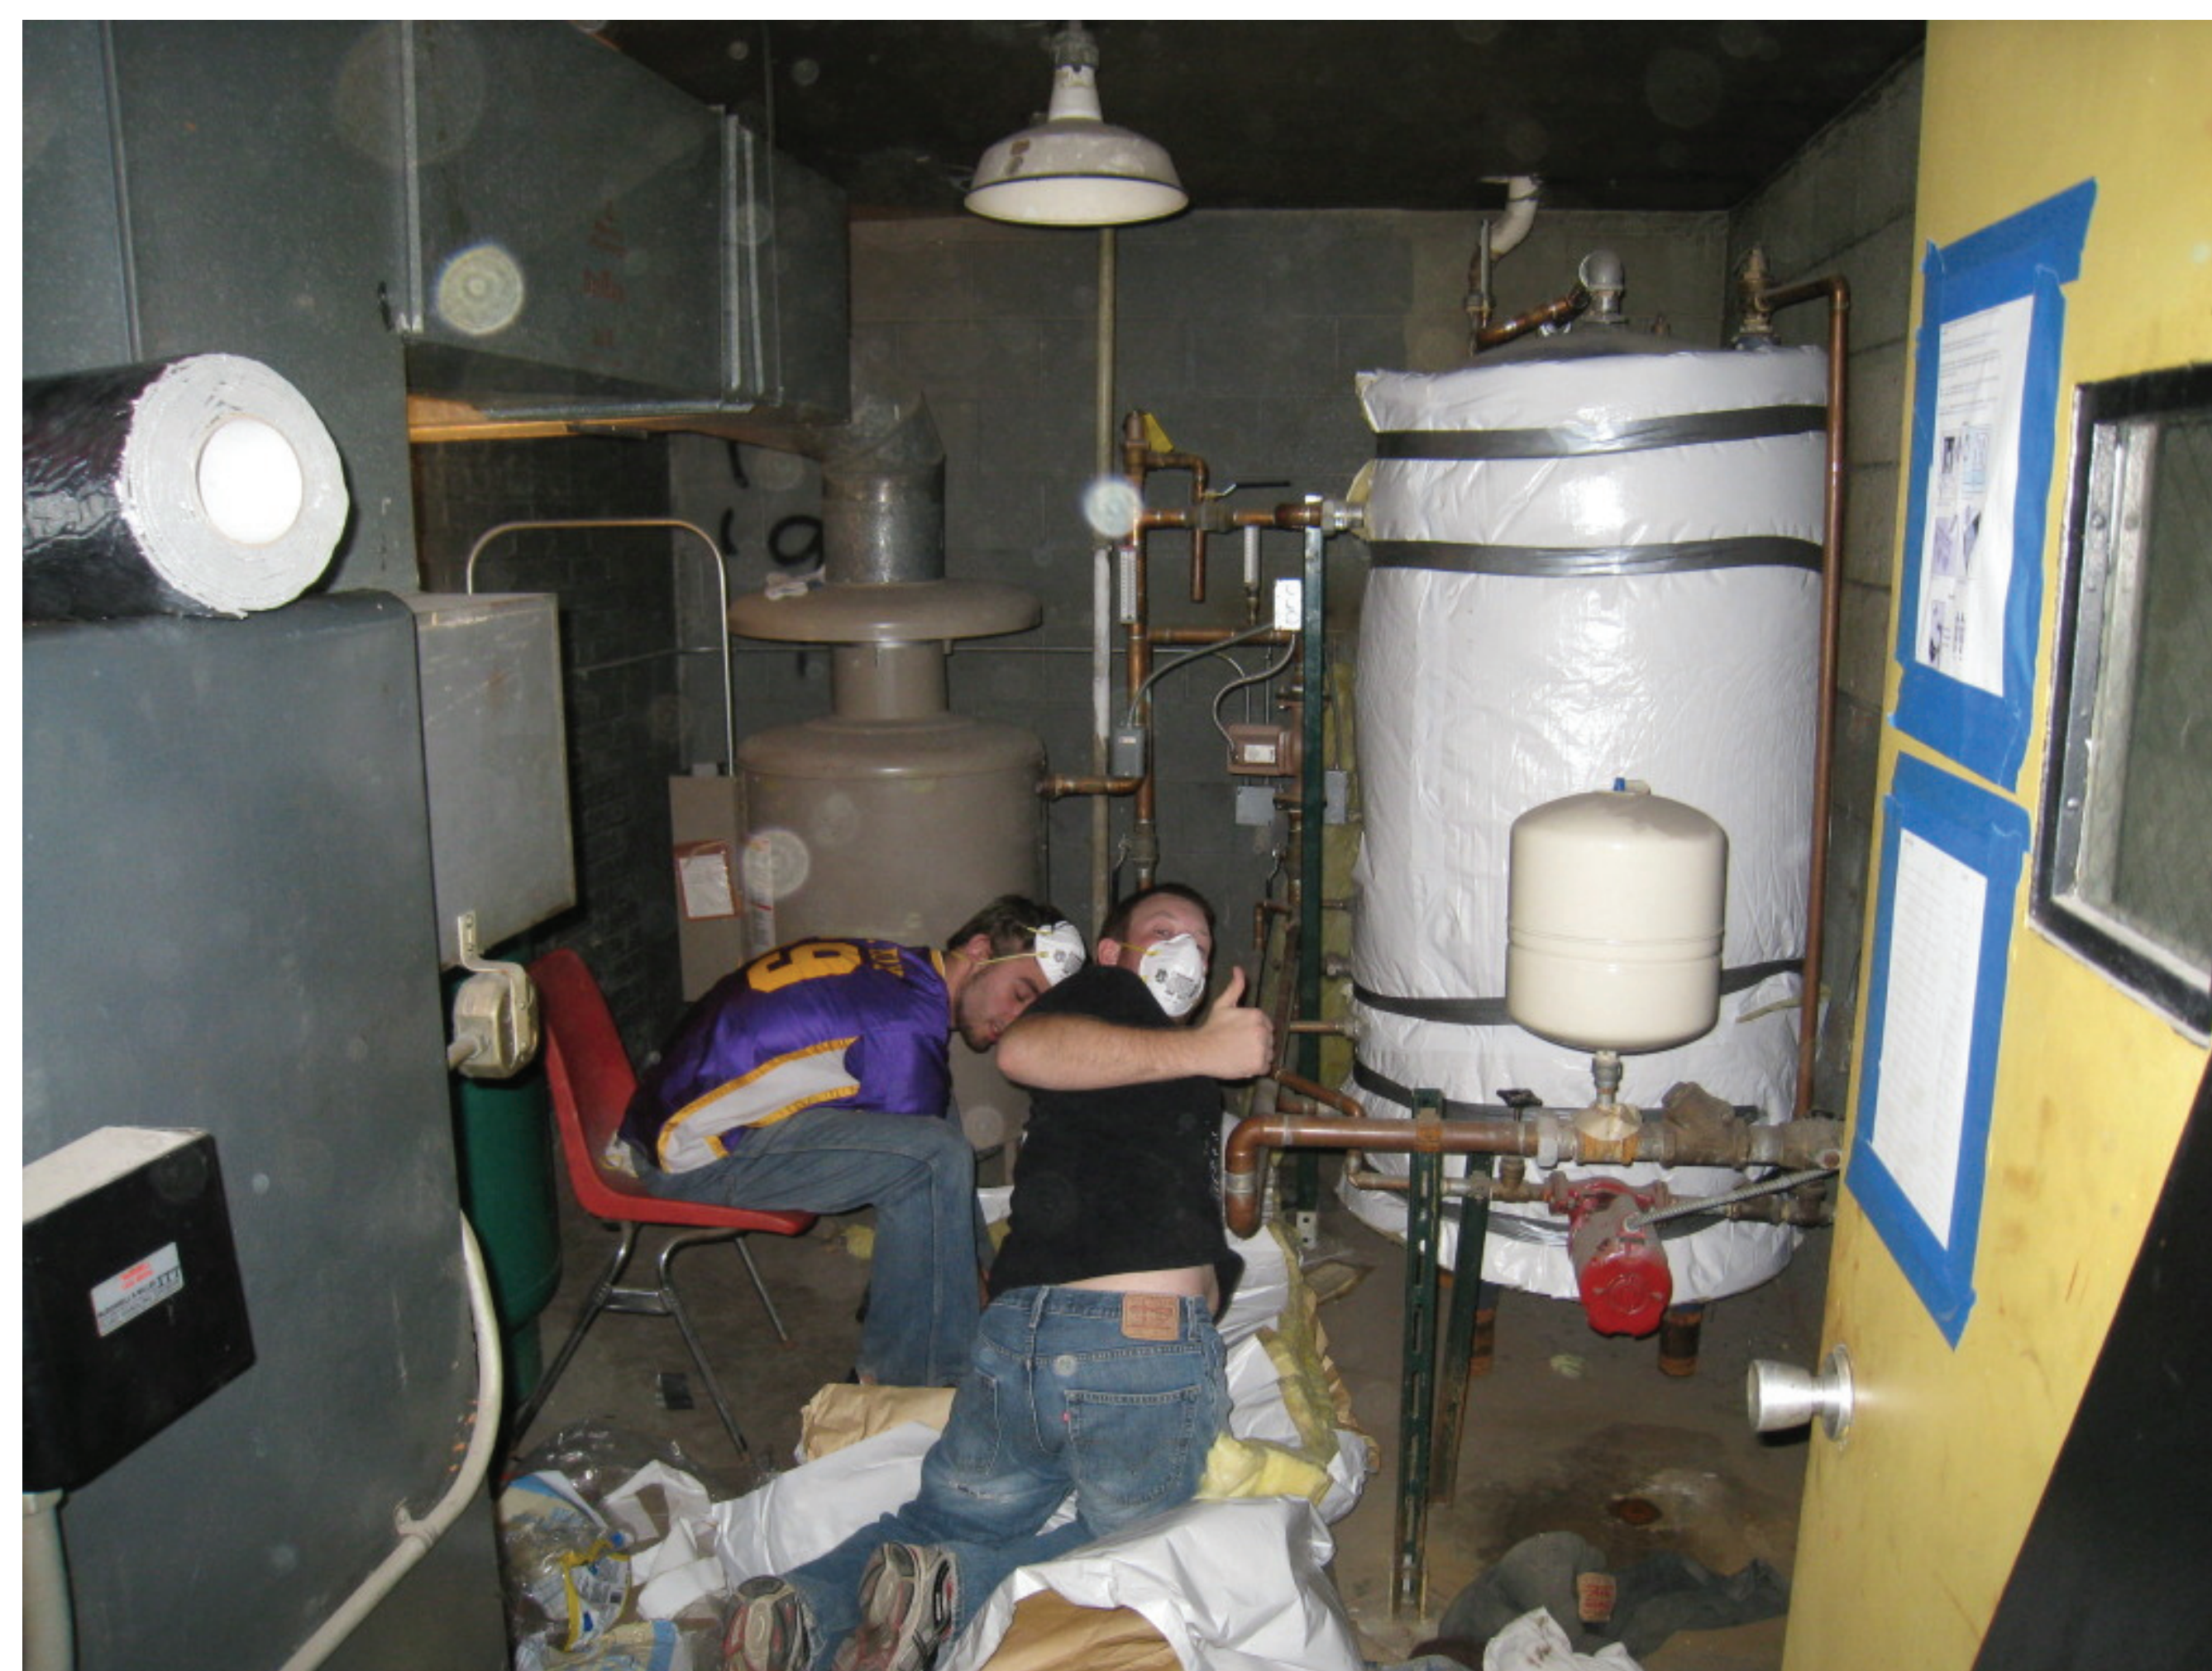
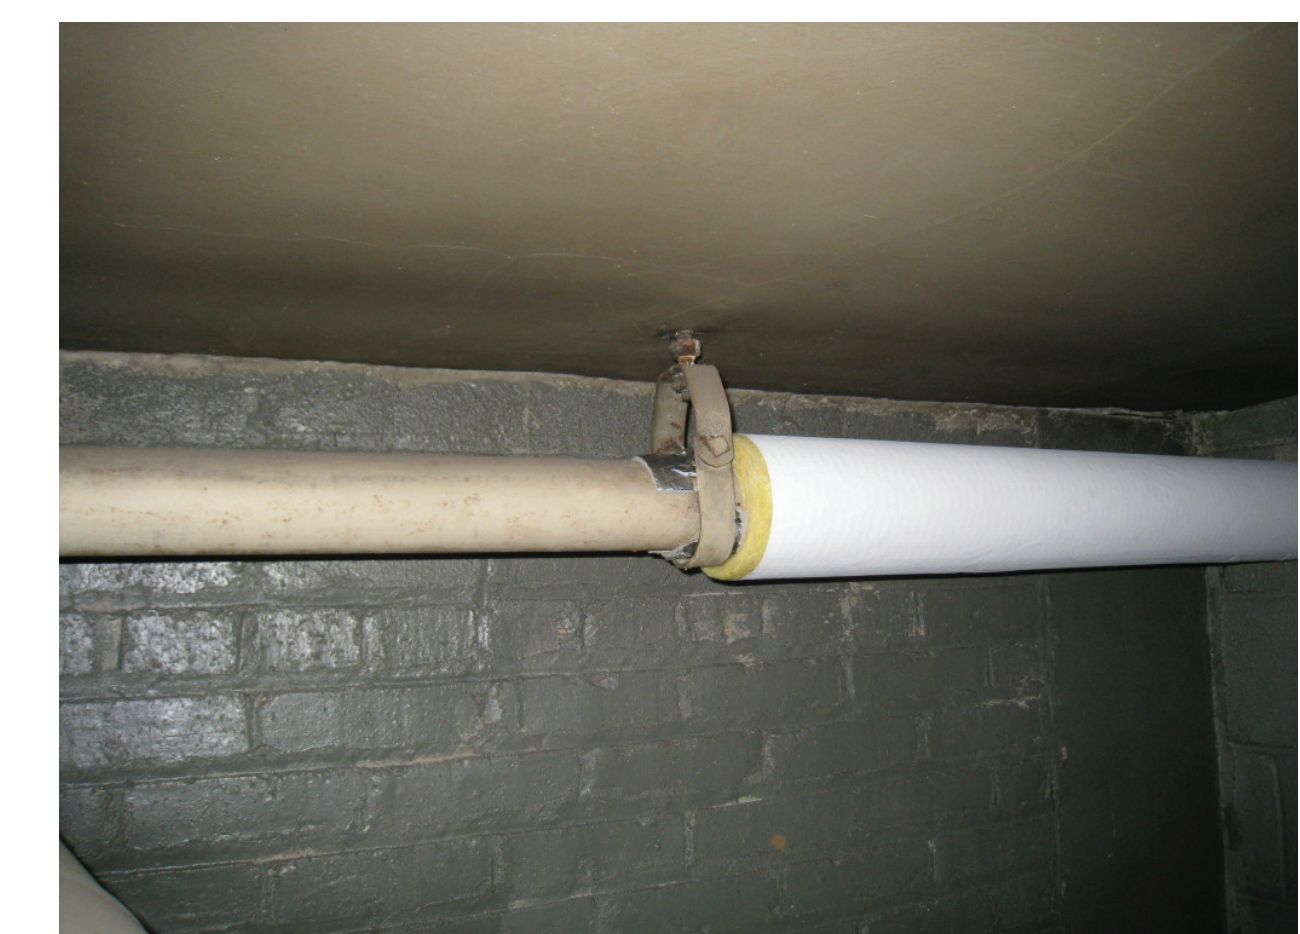
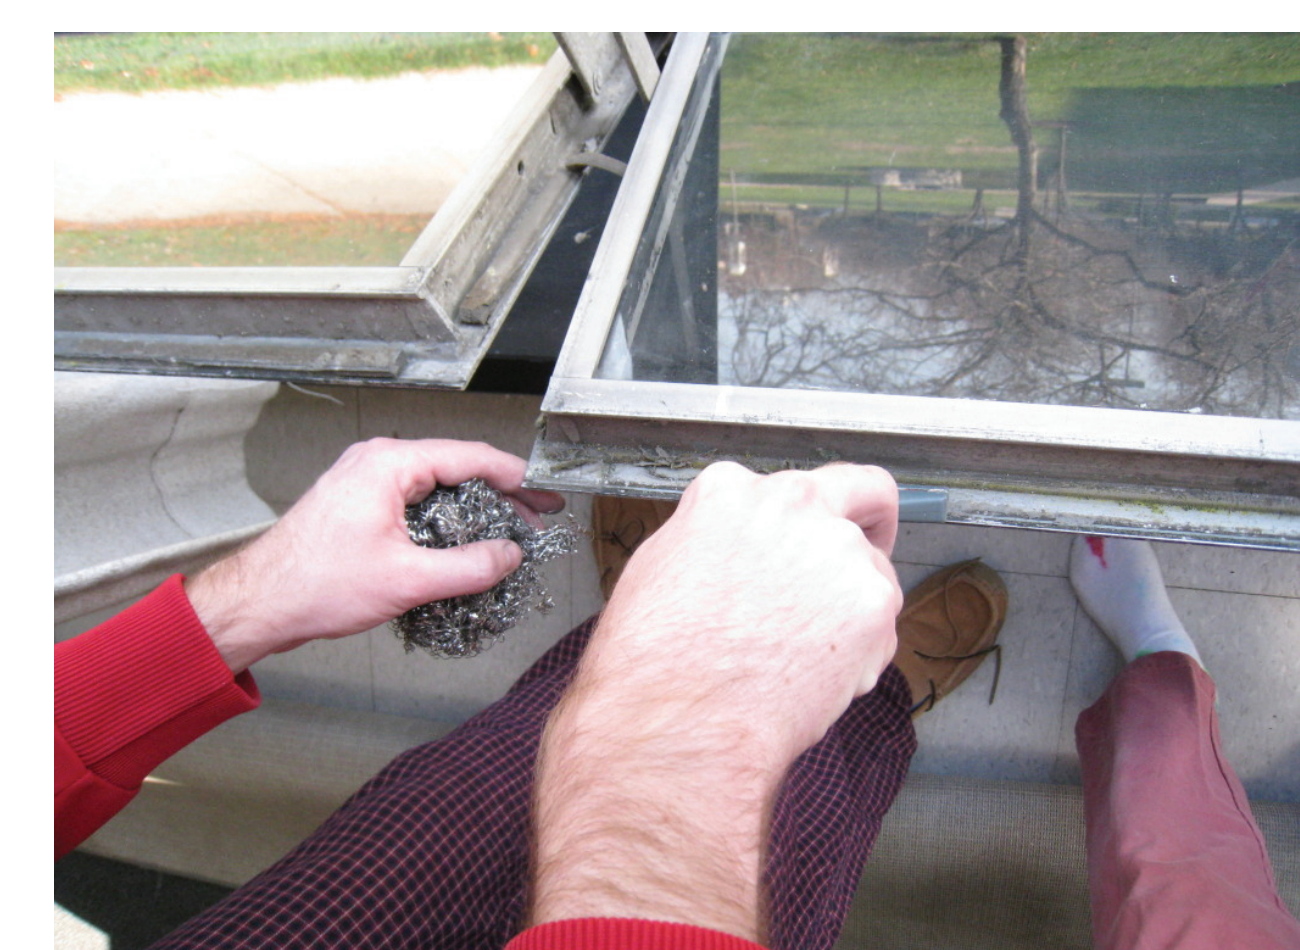
Part of the IPRO team's budget was spent to implement easily accomplished solutions to some of the shelter's most pressing issues. Brothers spent the day insulating the boiler tank and pipes which supply the shelter's radiant heating system--and which, previously, were entirely uninsulated. Secondly, new weather stripping was applied to the first floor's operable windows to help reduce air infiltration. Lastly, the industrial refrigerators in the kitchen were cleaned in order to optimize performance and reduce energy use.
