MATERIAL RENOVATION

To create a realistic proposal for renovating and restoring Crown Hall to Mies Van der Rohe's original vision while still keeping the building functional for today. By following guidelines for its new landmark status and last semester's research on the high priority problems of the building we created a plan of restoration that is hopefully comprehensive enough to put into effect as soon as possible.

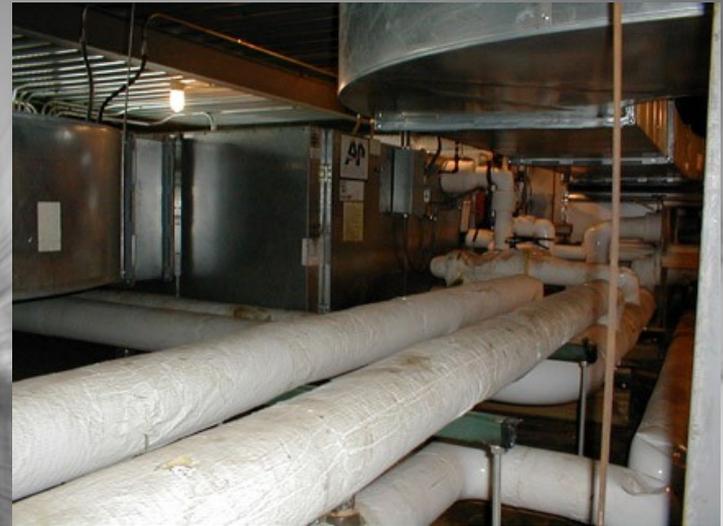
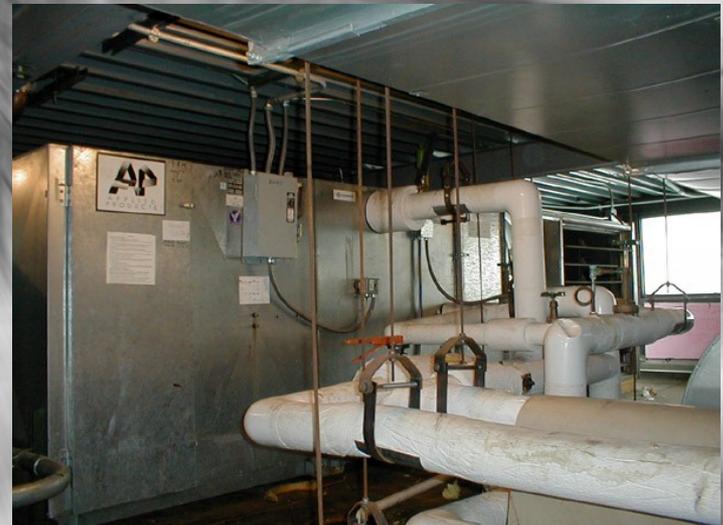
- Mechanical
 - There are two main components to the mechanical system. The heating and cooling system which is known as the Delta system.
 - We could potentially have Siemens system installed in Crown for a fee of at least \$46,000.
 - Instead it seems to make more sense to focus on elements such as thermal insulated glass before revamping the system.
 - Crown has more temperature issues because of its steel and glass design not because of the mechanical equipment.
 - Second main component is ventilation. This consists of three floor mounted horizontal discharge air handlers and sidewall propeller exhaust fans, all of which are located up in the Penthouse.
