# History of Greek Living at IIT

# Where we are now

#### **Original Project Objectives**

- Renovation(s) Proposals
- Facility Planning
- Sustainable Fraternity Living
- Long Term Goal Planning for the next 50 yrs

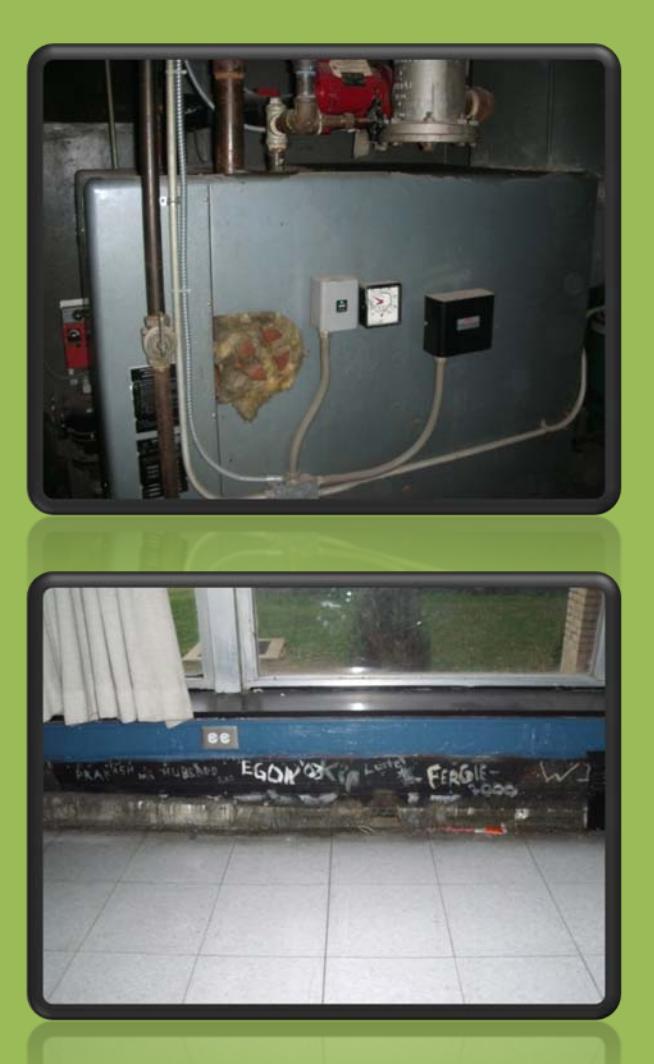
- Inefficient Boilers
- Poor Control System
- Un-insulated Pipe and Water Tanks
- Problems w/Radiant Fin Tubes

- Replace Boiler
- Preventative Maintenance
- Insulate Pipe
- Improve Control Systems
- Solar Thermal Alternative
- Service Day

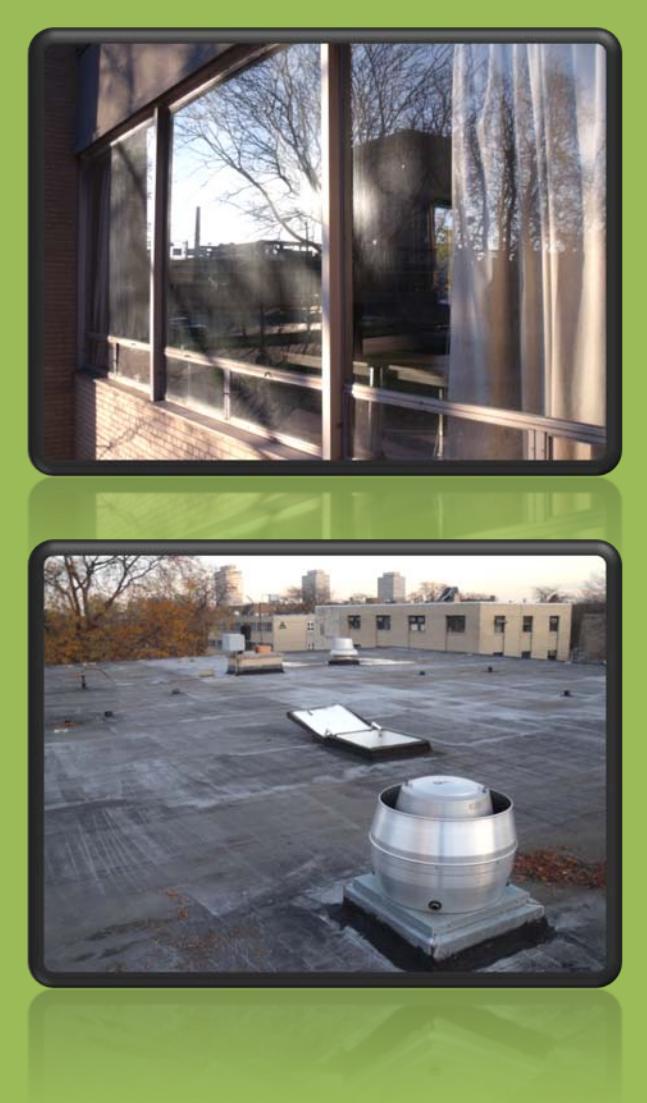
- Windows
- Roof
- Walls
- Doors
- Total R-Value: 3.45

- Replace Windows
- Weather stripping
- Better Insulate Roof
- Provide Insulation for Ext. Walls
- Service Day

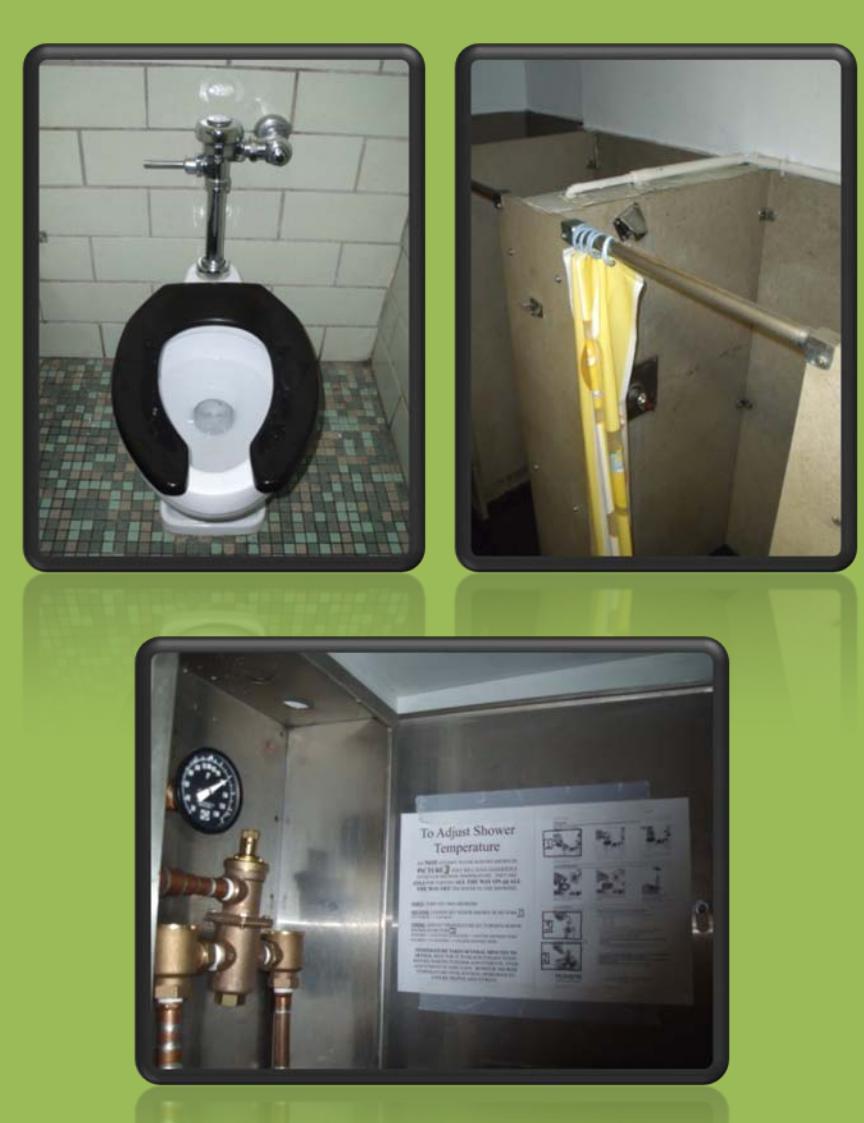
- Excessive Water Usage
  - Toilets
  - Urinals
- Shower Controls

- Introduce Water Saving Technology
- Improve Shower Controls

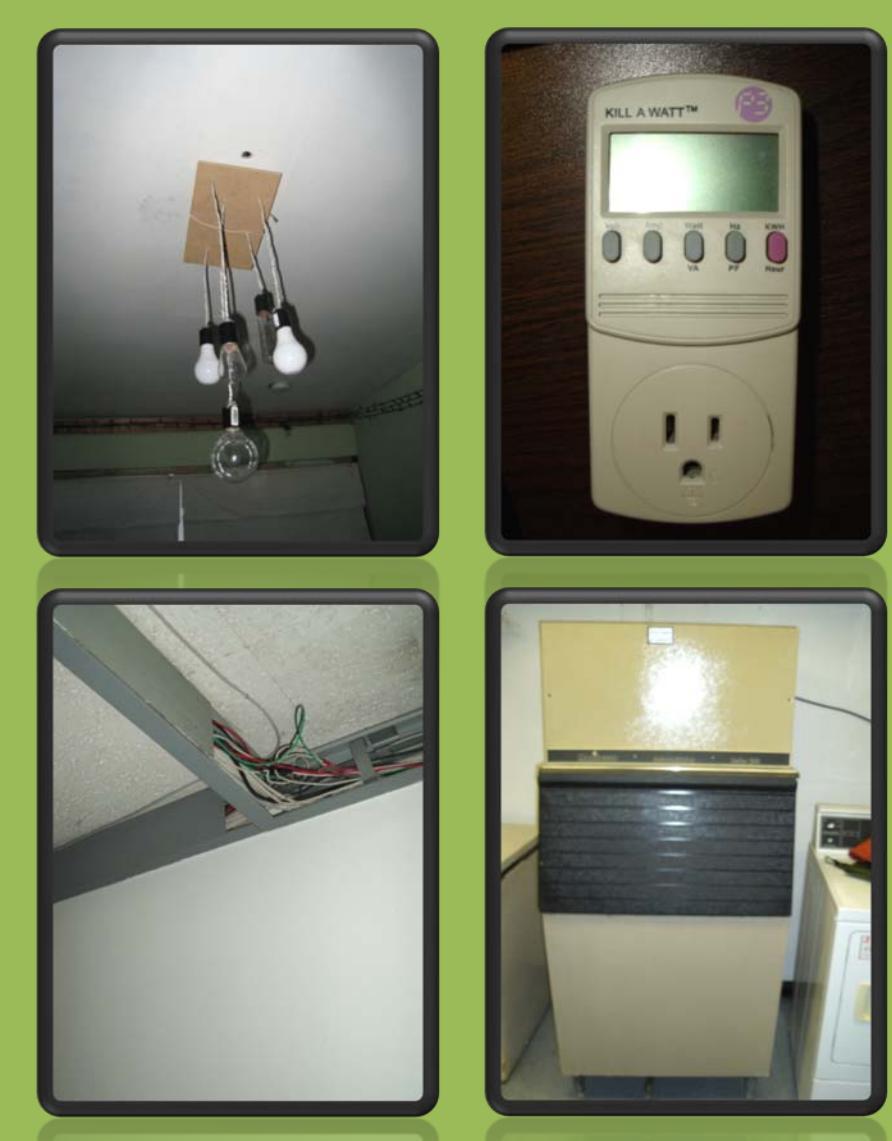
- Lighting
- Appliances
- Wiring

- Lighting Plan
- Occupancy Sensors
- Energy Saving Appliances
- Photovoltaic Cells

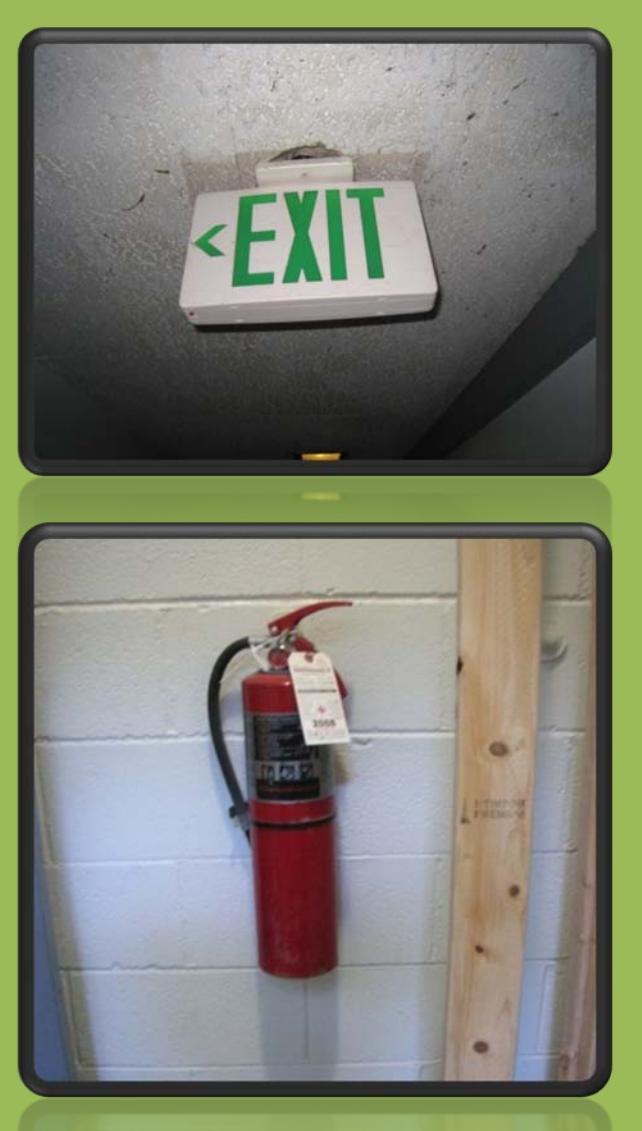
- No centralized alert system
- Minimal Fire Safety

- Hard Wired Detection and Alert System
- New, up-to-code Exit Signage
- Emergency Lighting

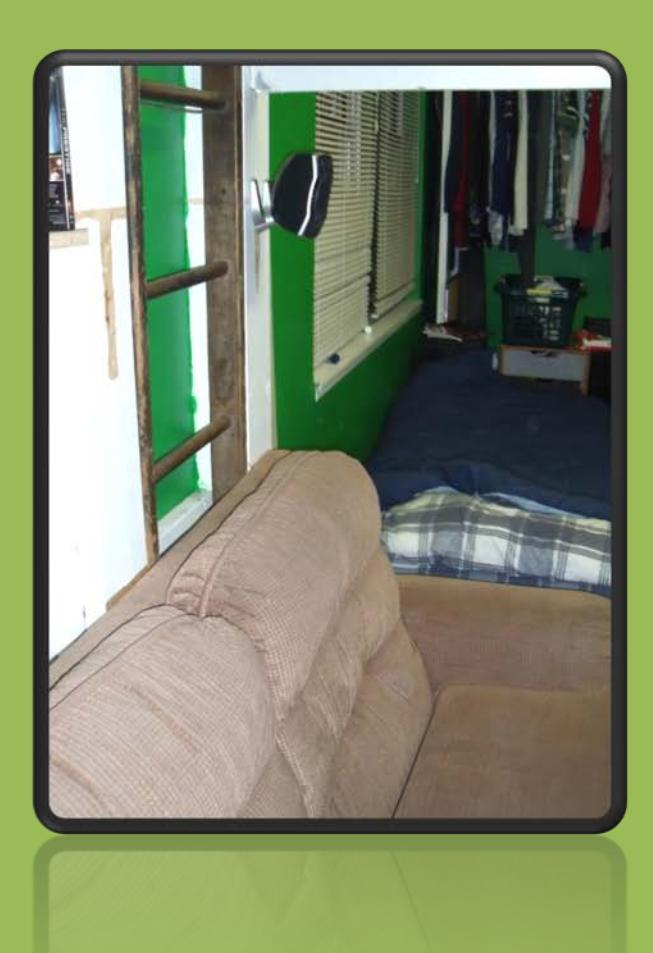
- Electricity
- Recycling
- Heat Distribution

- Education of Building Residents
- Recycling Program

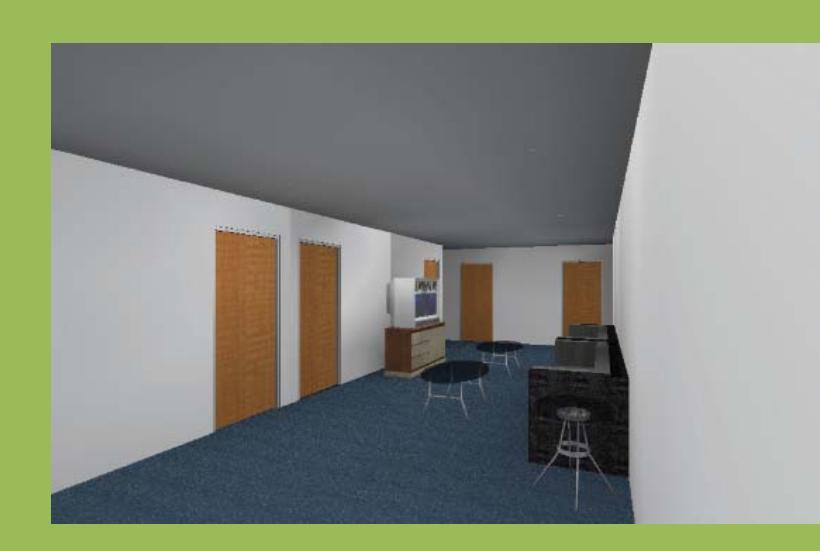
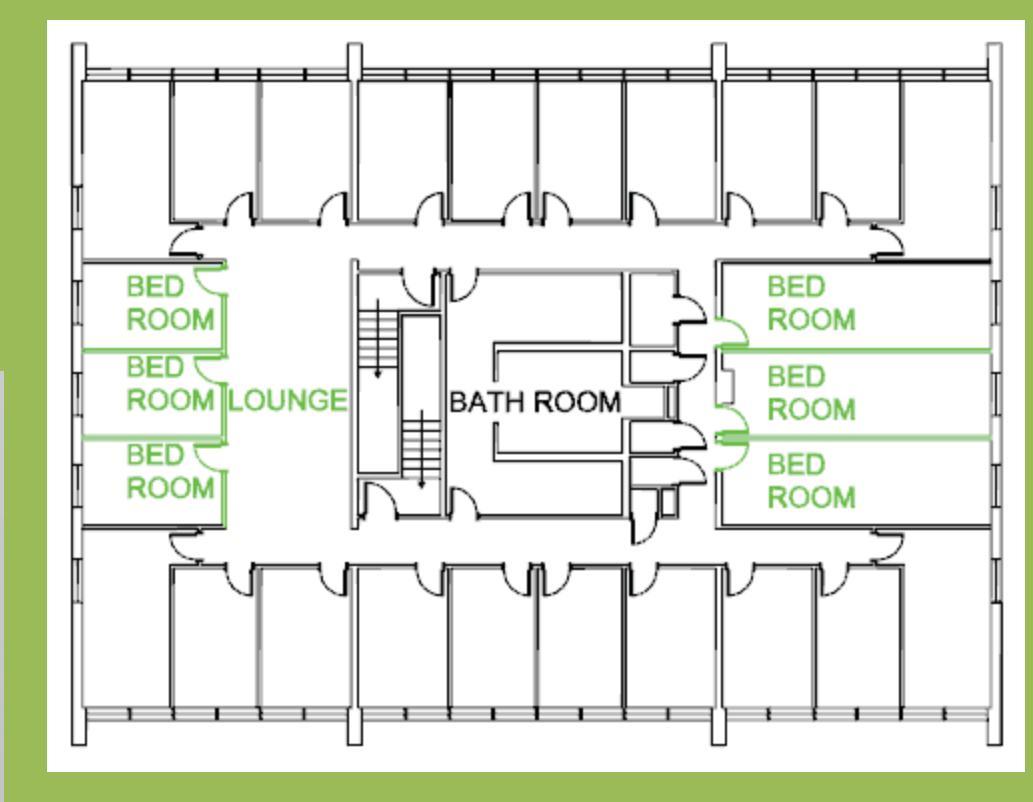
# **Proposal One: Minor Renovation**

- Second Floor
  - Additional Private
     Bedrooms
  - More open space

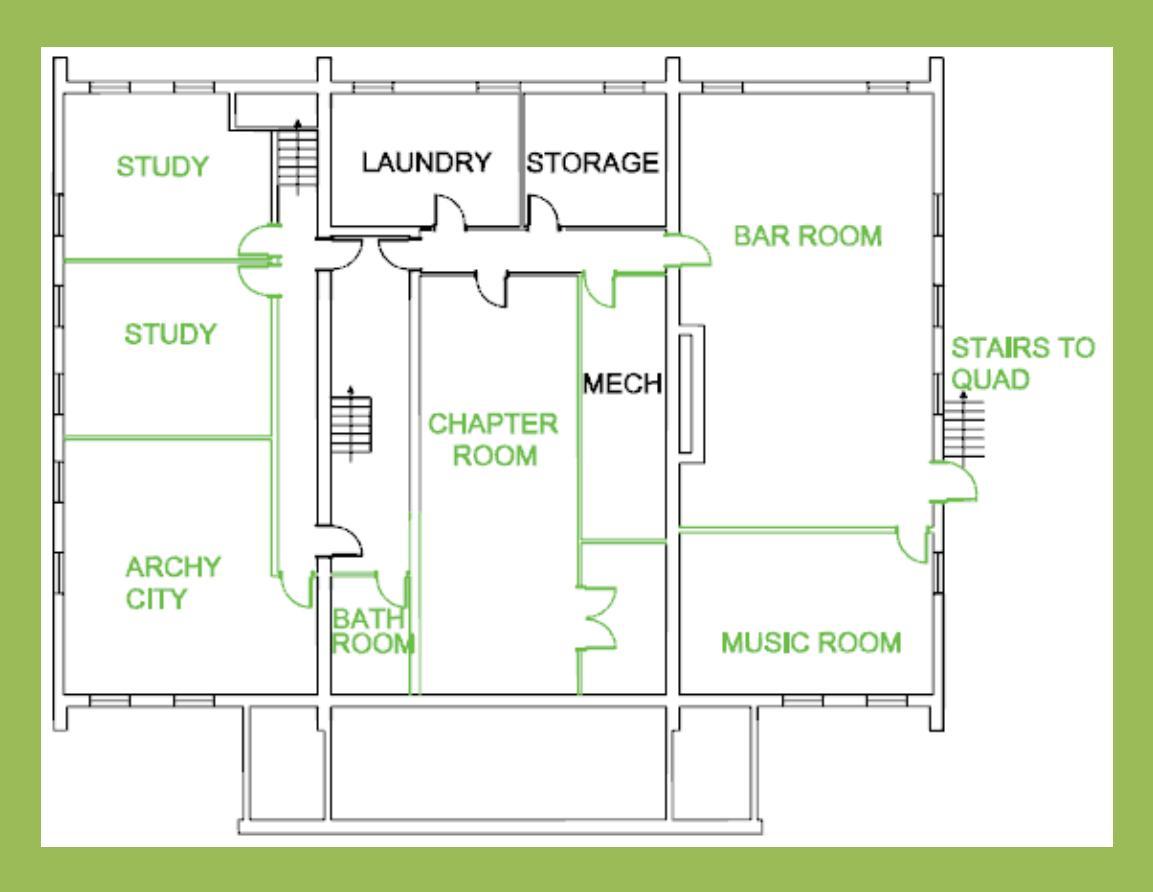
# Proposal Two: Intermediate Renovation

- Basement
  - Excavation Plan
- Quad-side Entrance

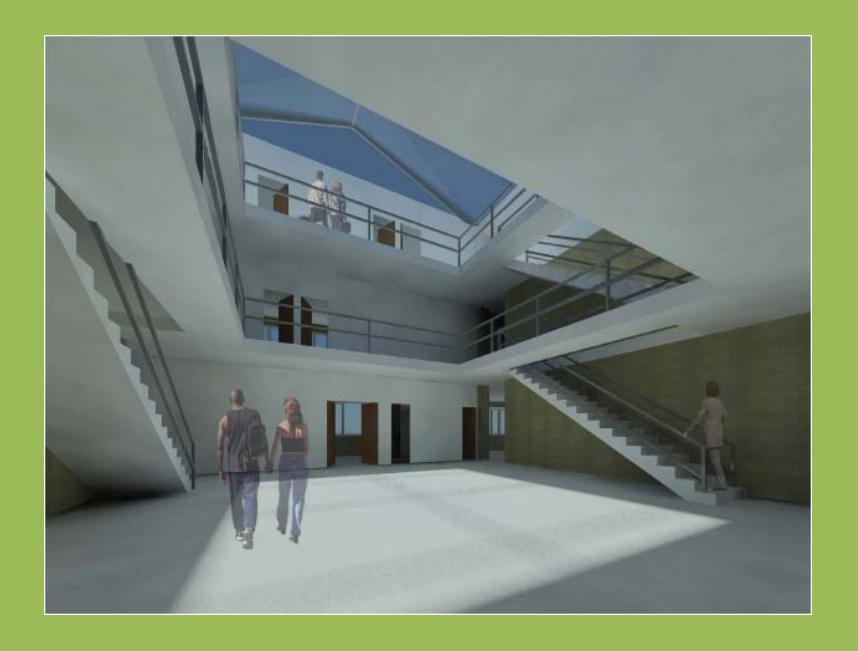
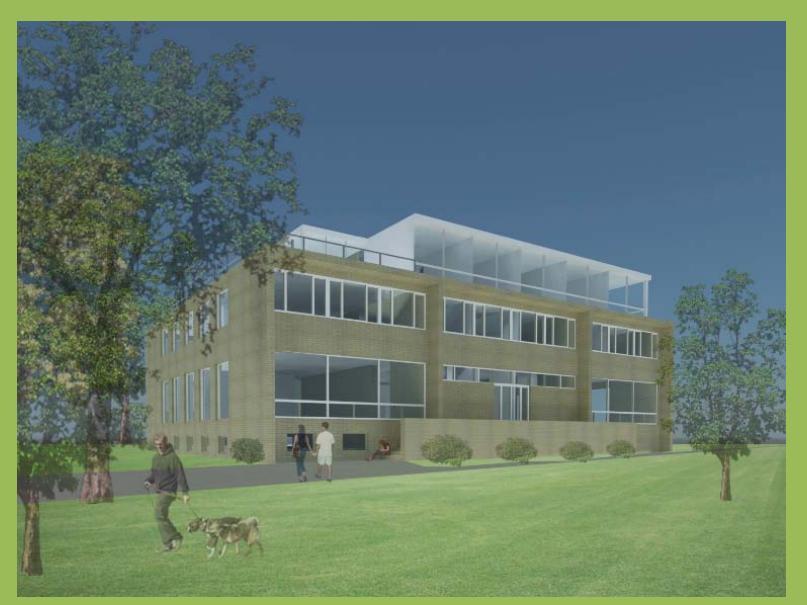
# **Proposal Three: Major Renovation**

- Third Floor Addition
- Central Atrium

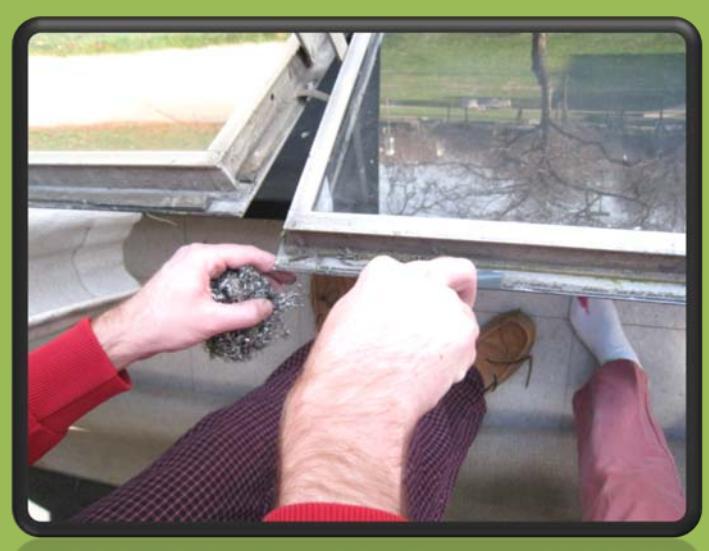
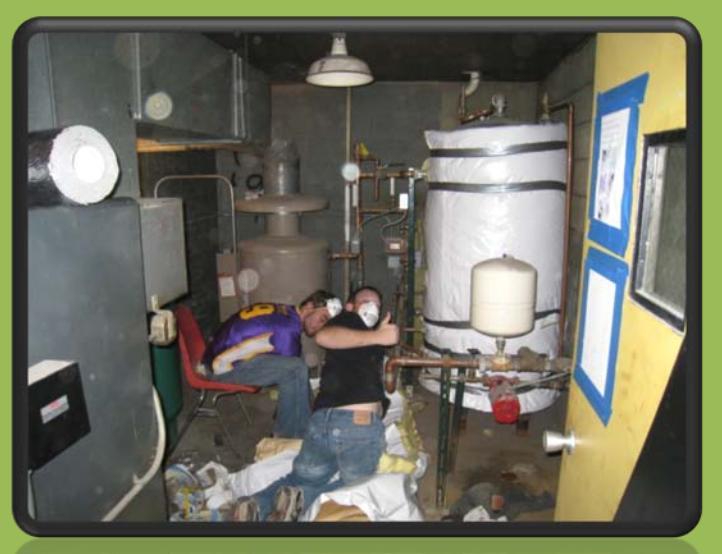
# Service Day

- Clean Refrigerator Coils
- Weather Strip Operable First Floor Windows
- Insulate Hot Water Piping
- Insulate Hot Water Storage Tanks
