Energy & Facility Planning for Delta Tau Delta Chapter House

Fall IPRO 311 Project Team - Interprofessional Projects Program

December 2009

I PRO 311
Energy & Facility Planning for Delta Tau Delta Chapter House

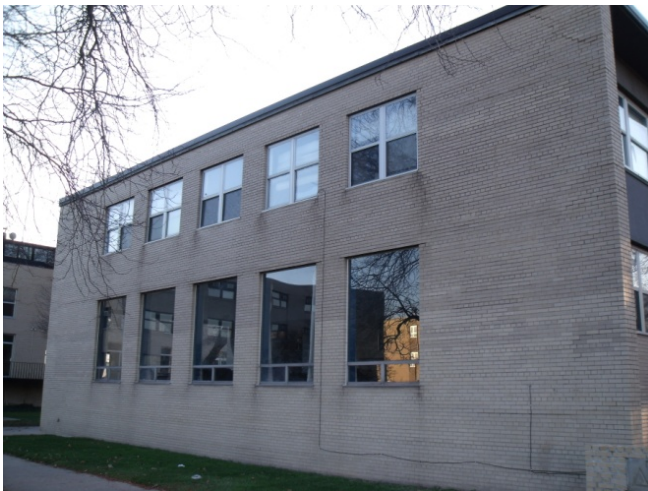
After inspection of the windows on the main floor of the building it is quite obvious that they are outdated and insufficient. From a deep look into past renovation records it seems as if the windows and frames are original. Some of the lower hopper windows are non-functional, and some have been permanently closed. The thermal seal on all of the hopper windows is also insufficient. The panes are ¼” thick glass with an R-Value of 0.91.

Current windows of the Delta Tau Delta chapter facing east

As the winter is upon us, temporary solutions should be performed to reduce the energy lost through the poorly sealed windows. After the winter is over, it is recommended to hire Harmon Glass to replace the windows on the first floor.

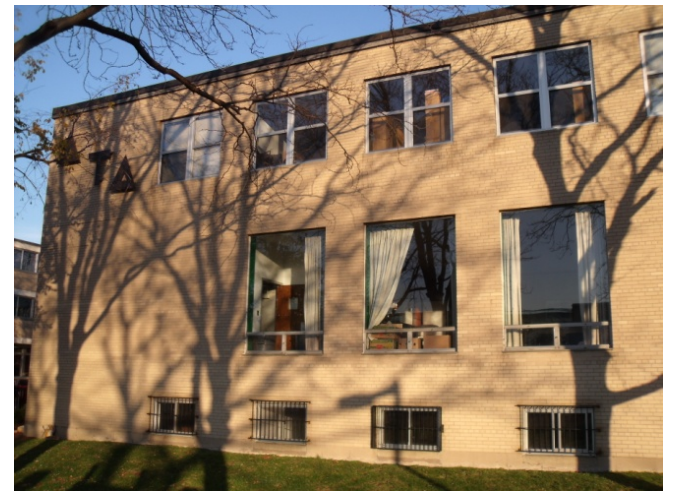
The windows on the second floor were replaced in 2002, but despite their recent installation have run into problems as well. Some of the aluminum frames have been damaged due to negligence while putting in and taking out air conditioners. It is also unclear as to whether or not the windows are thermally broken as often times, condensation forms on the inside of the window. From speaking with the residents of the building, there is suspicion that in some units during the winter there is considerable air infiltration.

Current windows of the chapter house on its west side

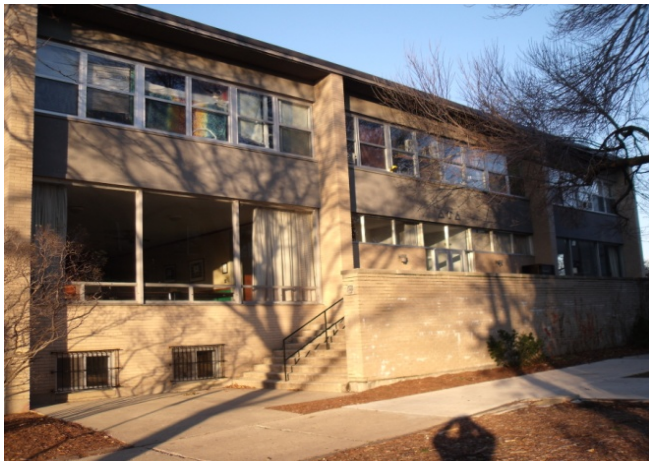
Delta Tau Delta – Windows on the south side of the building

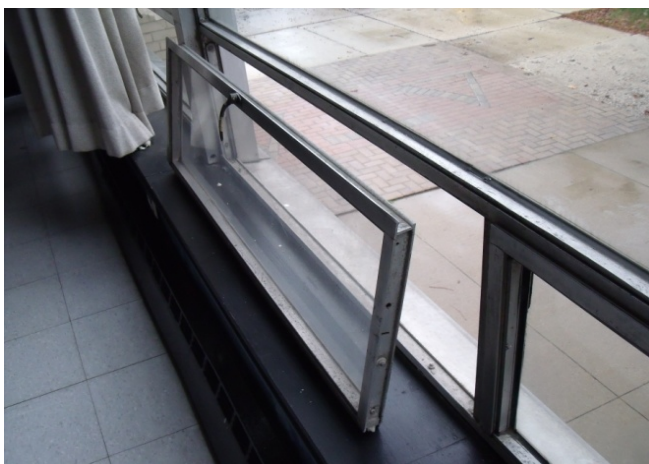
Many of the windows in the building have aged over time, some becoming inoperable. In this picture one inoperable window is shown.

This option includes minor repairs to temporarily prepare the windows for winter seasons. These minor repairs include permanently closing any non-functional hopper windows by simply screwing them in place. This would also include, providing weather stripping in all operable seals and possible resealing/re-caulking all aluminum/glass joints.

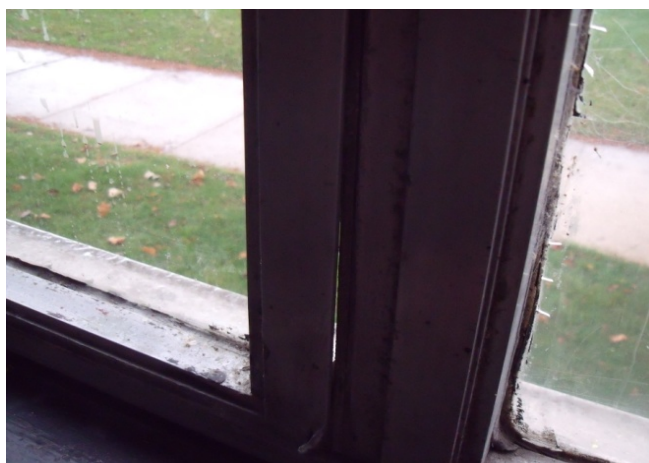
Air infiltration into the structure is one source of high energy costs. Here one can see a visible gap in the windows allowing air to easily flow in and out of the building.

Air leaks are most abundant around the windows and doors. This can be remedied by renewing the weather stripping and door sweeps. The windows will be harder to fix than the doors because the leakage is built into the frames. The cost of replacing windows is very high and we will never see a payback.

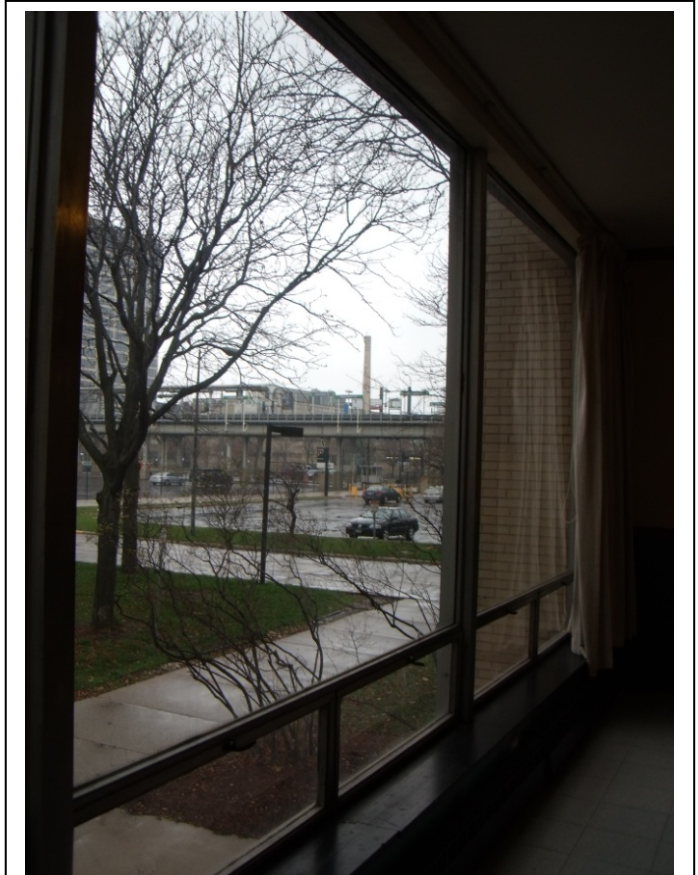
Interior view of one large span window found on the building's first floor.

The final option would be to completely replace all windows on the first floor of the building. Two different companies were contacted and supplied quotes for the replacement of the first floor windows. These quotes are attached. The R-Values of the products that were proposed were requested, but were never provided by the supplier. The estimated value for the proposed new windows is 3.13.

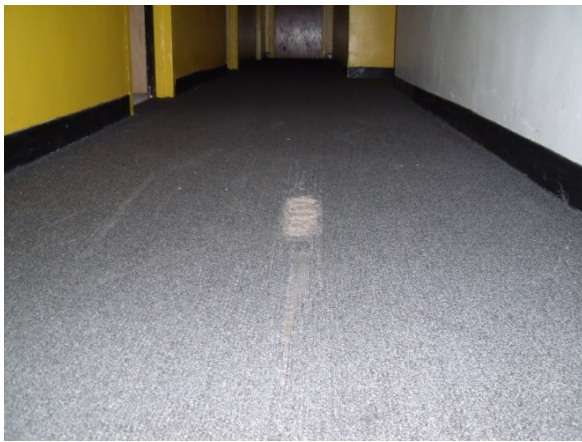
Due to the high traffic nature of a fraternity house, after about 10 years the tile and carpet show disrepair. In many places, tiles are broken and cracked and there are several places where the carpet has runs. Another problem with the current system is that the tile requires a lot of attention as it is stripped and re-waxed at the beginning of every academic semester. During the stripping and waxing process, it has been noticed that the adhesive holding the tiles down has started to leak between the tile joints.

Existing run of carpet found in the upstairs hallway of the Delta Tau Delta chapter house. Note of the wear of the carpet in the center of the photo.

Replace both tile and carpet throughout whole building.

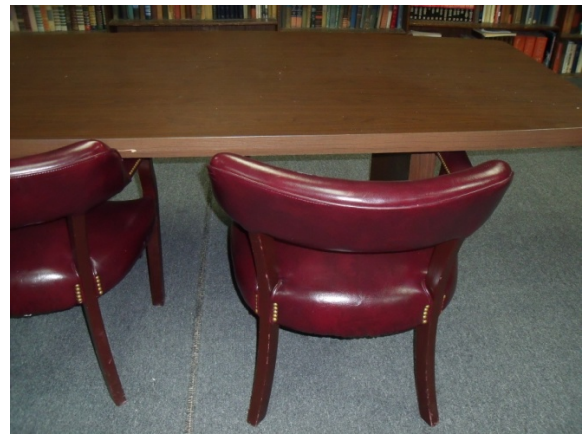
Existing run of carpet found in the chapter house's library. After years of use the carpet has begun to come apart at its seams.

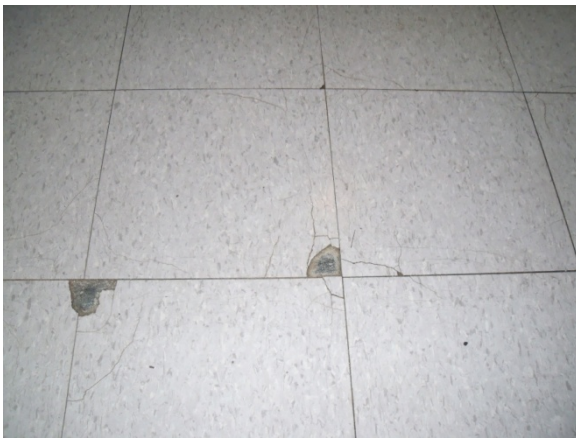
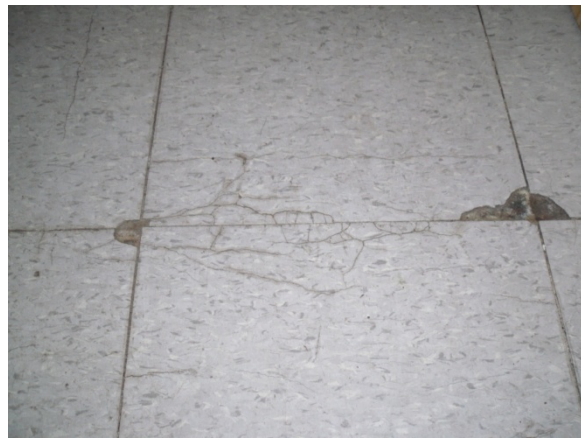
There are several areas in the building where tile is used to cover the floor. After many years of wear and tear the existing tile floor has begun to chip and crack way as pictured above.

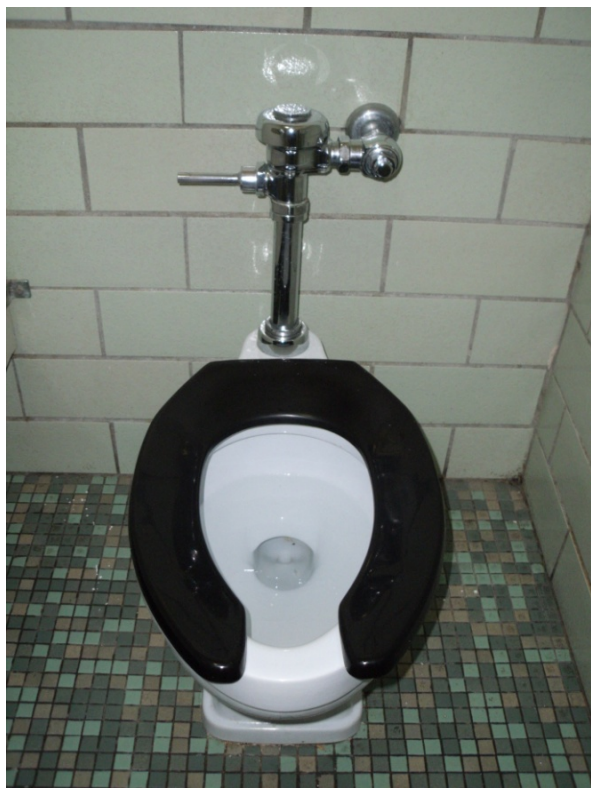
When reviewing the sustainability of the building, it is clear that the bathroom fixtures are quite wasteful when it comes to water consumption. The current standard for the amount of water consumed by toilets is 1.6 gpf. The four toilets in the bathroom all use 3.5 gpf, which is over double the amount of the standard system. The same can be said about the water consumption of the four urinals in the bathroom. The current standard for urinals is 1.0 gpf. While the urinals in the current building use the same amount, there is much technology available to reduce greatly urinal water consumption.

View of current toilet fixture found throughout the DTD house. All toilets found throughout the house use 3.5 gallons per flush.

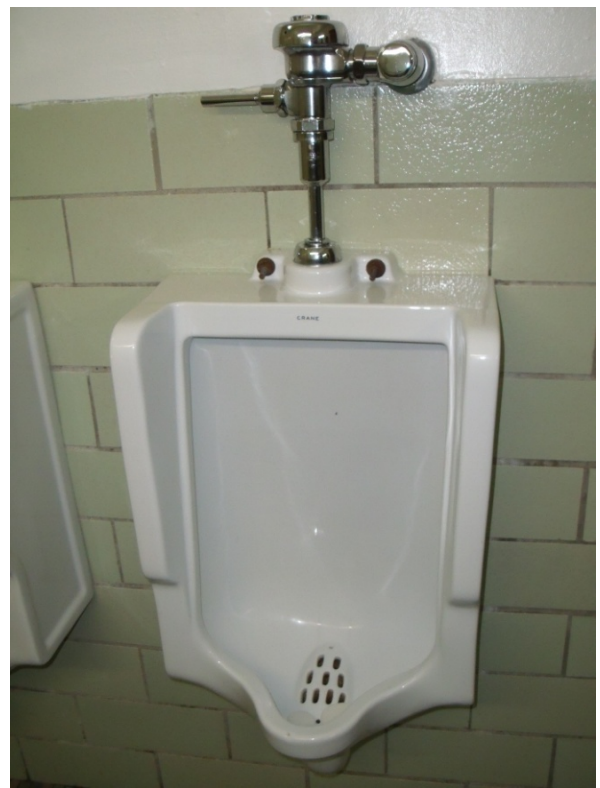
This 1.0 gallon per flush urinal fixture is the current urinal fixture of choice in the building.

The most interesting option for replacing the urinals is the water-less urinal made by Falcon Water-free Technologies. These urinals consume absolutely zero water. The waterless urinal uses a replaceable cartridge with a sealant liquid layer through which urine passes. The sealant liquid provides an airtight and aromatic barrier between the urine and the atmosphere. Cartridges need to be replaced every 4 months.

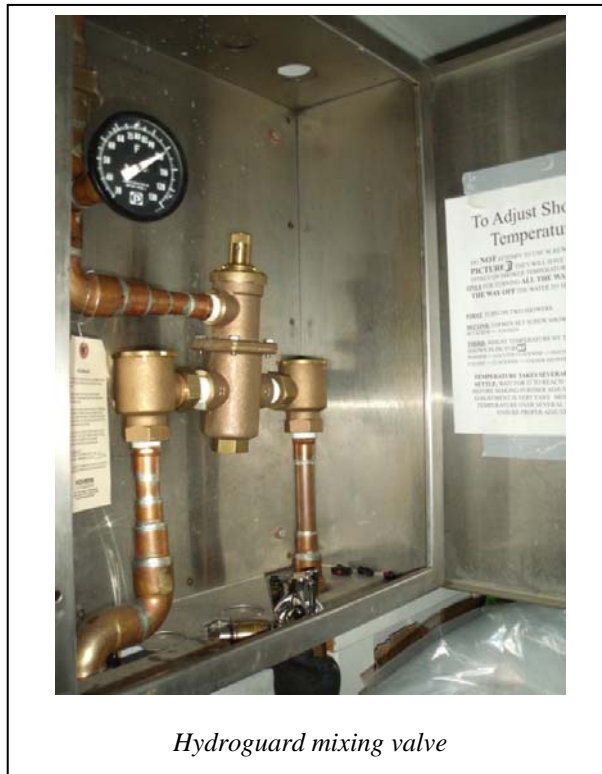
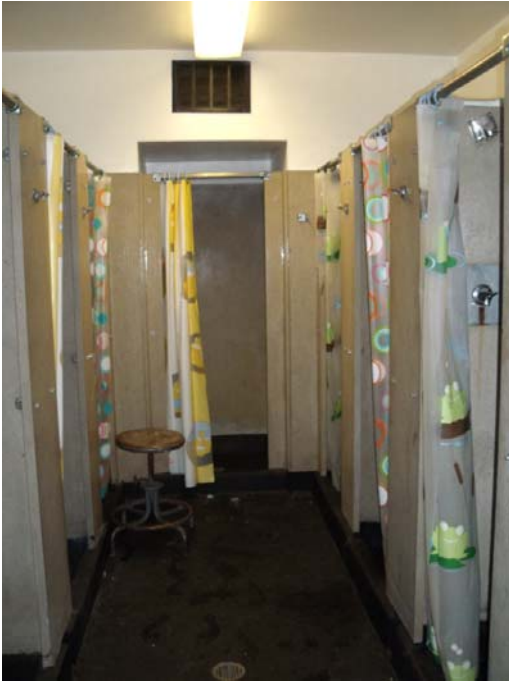
There are 7 showers in the shower room. The showers only have the capability of running hot water. The water temperature for all showers is controlled by the central Hydroguard mixing valve.

Layout of shower stalls in DTD upstairs bathroom

It is fairly clear that in any contemporary student living situation it seems completely necessary to have temperature control in all showers. A plumber was contacted to present a quote for allowing the possibility of having temperature control in all showers. The quote from John's Plumbing is for \$6,350. The scope of the project was to remove the existing piping and valves, and to run both hot and water pipes to each shower with new valves and faucets.

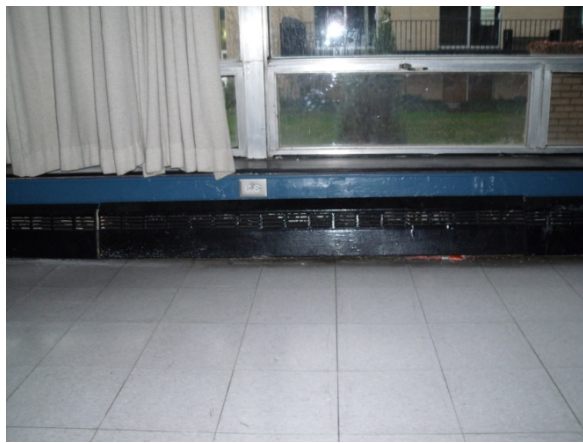
The current mode for heat distribution is through radiant fin tubing around the perimeter of the building. In almost all places, the fin tubes lie directly below large window spans which as stated earlier are very poor thermal barriers. Larger rooms such as the living room and the dining room have a hard time being heated sufficiently by the fin tubes. Also, there are many spots along the runs of piping that are dysfunctional. As part of making our heating distribution system more efficient, we looked into the possibility of installing a hydronic radiant floor heating system throughout the building.

Picture viewing one of the many runs of raditors that around found throughout the building.

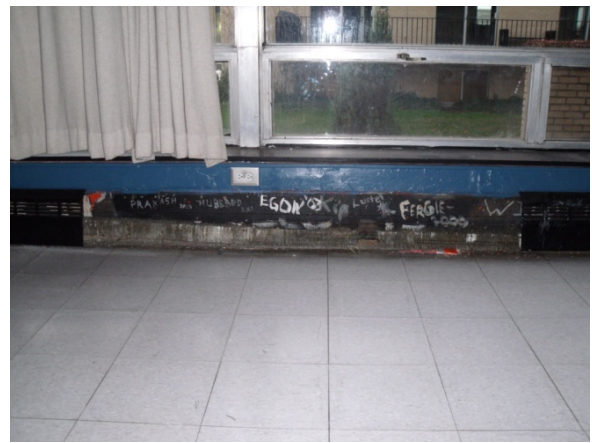
When the cover is removed its easily seen how the many of the fin tubes in the system have been bent or broken thereby hindering the performance of the system.

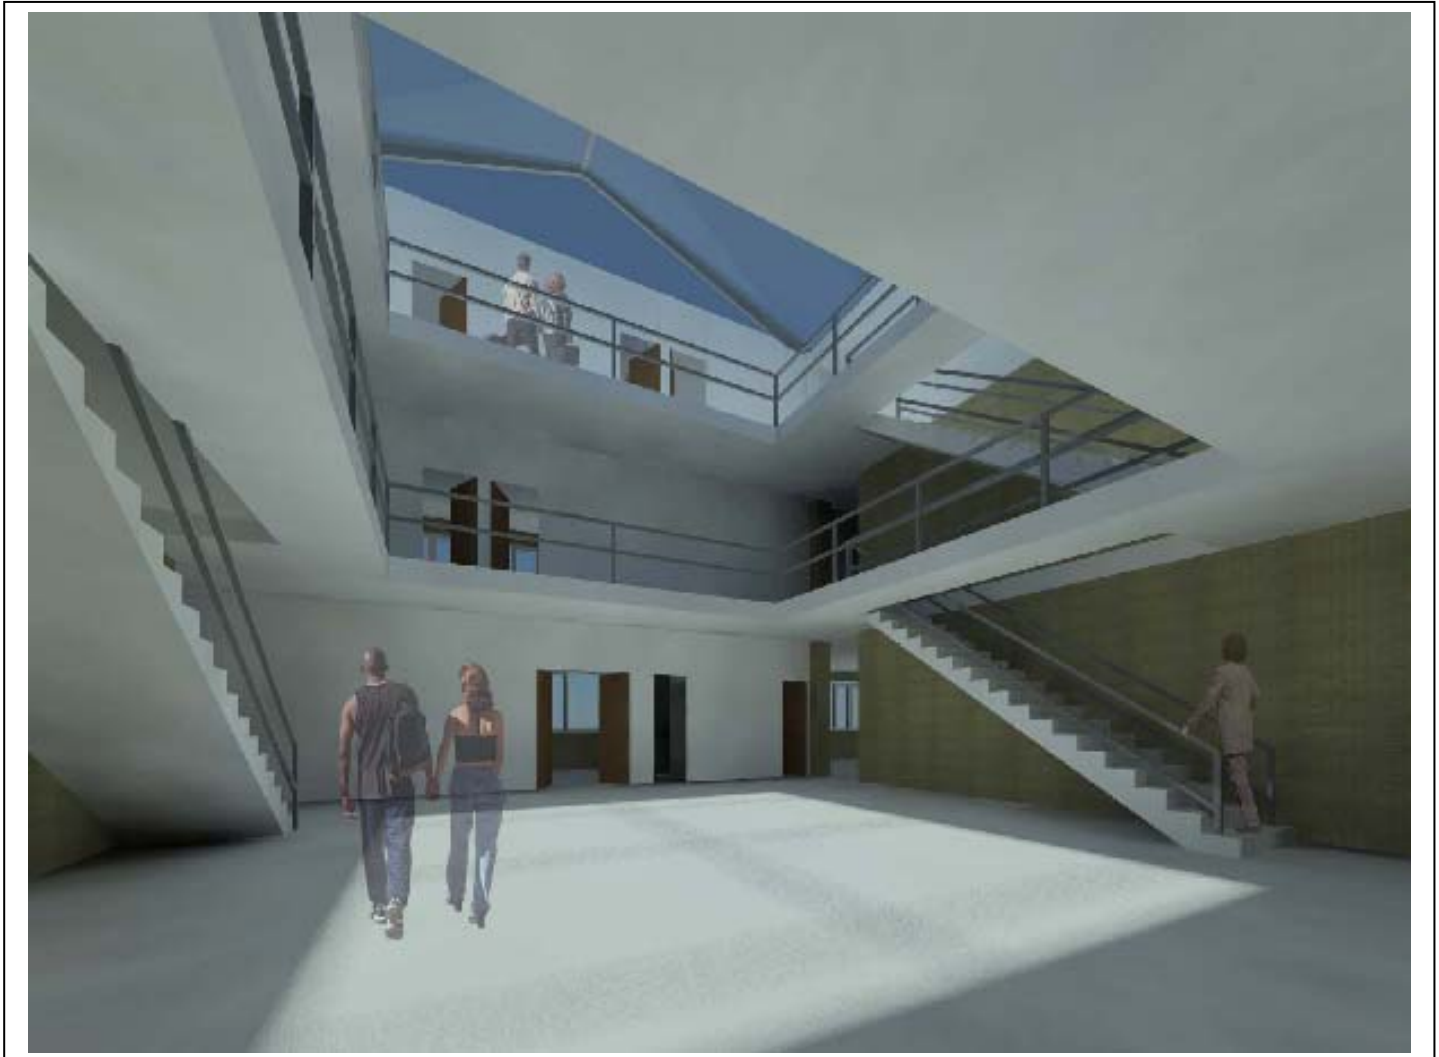
FINAL RENDERING INTERIOR

Rendering of the interior of the purposed atrium in the Delta Tau Delta house.

The final proposal involves adding a third floor and an interior atrium as a core in the center of the building. This scheme is a complete renovation of the interior and would leave the bearing walls intact but would require some kind of reinforcement. It opens up all of the circulation to the center atrium and makes the rooms slightly larger wrapping around the central circulation core. The top two floors consist of rooms with a smaller public bathroom on each floor and the second floor has a large study space that fills an entire bay of the house and the third floor allows for a lounge and an outdoor patio. The center atrium has a glass ceiling and windows that can be opened or closed so it can be used to supplement heating for the house in the winter and cooling through stack effect in the summer. Since it is in the center core of the building all rooms can be heated or cooled by it if the doors are left open allowing for natural ventilation and solar heating. Although this plan does not require excavation of the basement, it by far changes more of the existing building than any of the other plans and requires reinforcement of the bearing walls. With all of this new construction this phase is quite costly but most addresses the culmination of all of the problems the programming team found in its research.

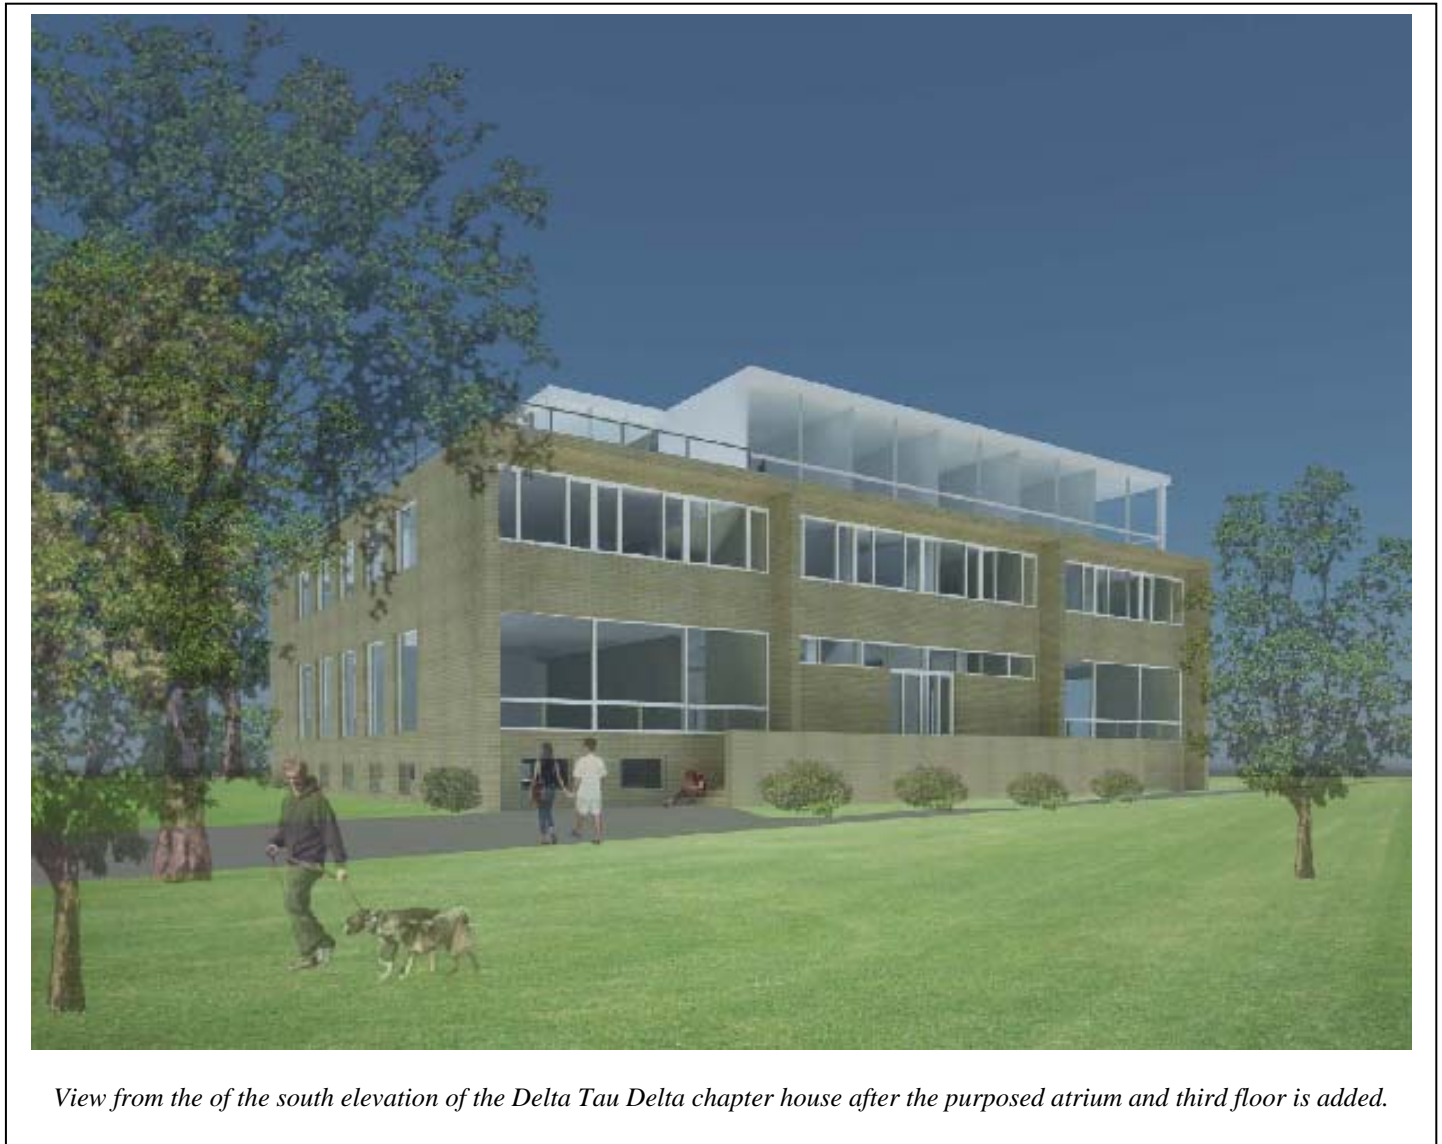
FINAL RENDERING EXTERIOR

View from the of the south elevation of the Delta Tau Delta chapter house after the purposed atrium and third floor is added.
